BLACK SLUICE

INTERNAL DRAINAGE BOARD

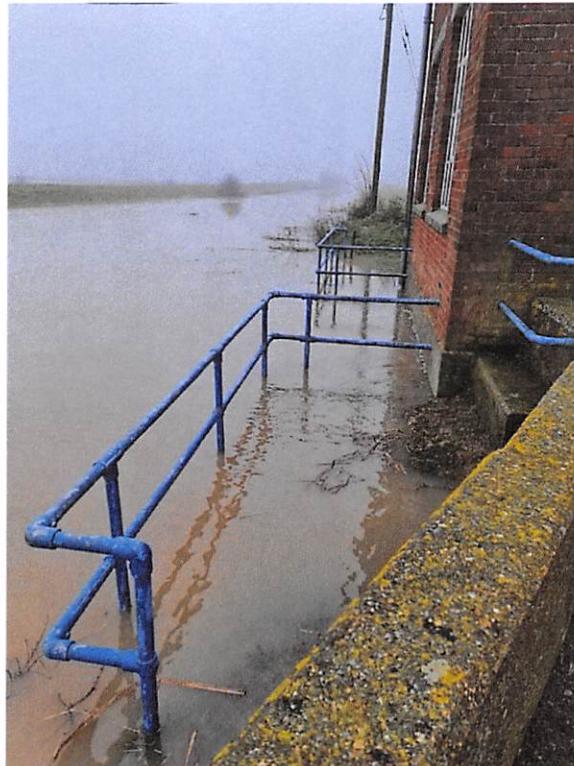
3. Culverts that have been reported as in poor condition

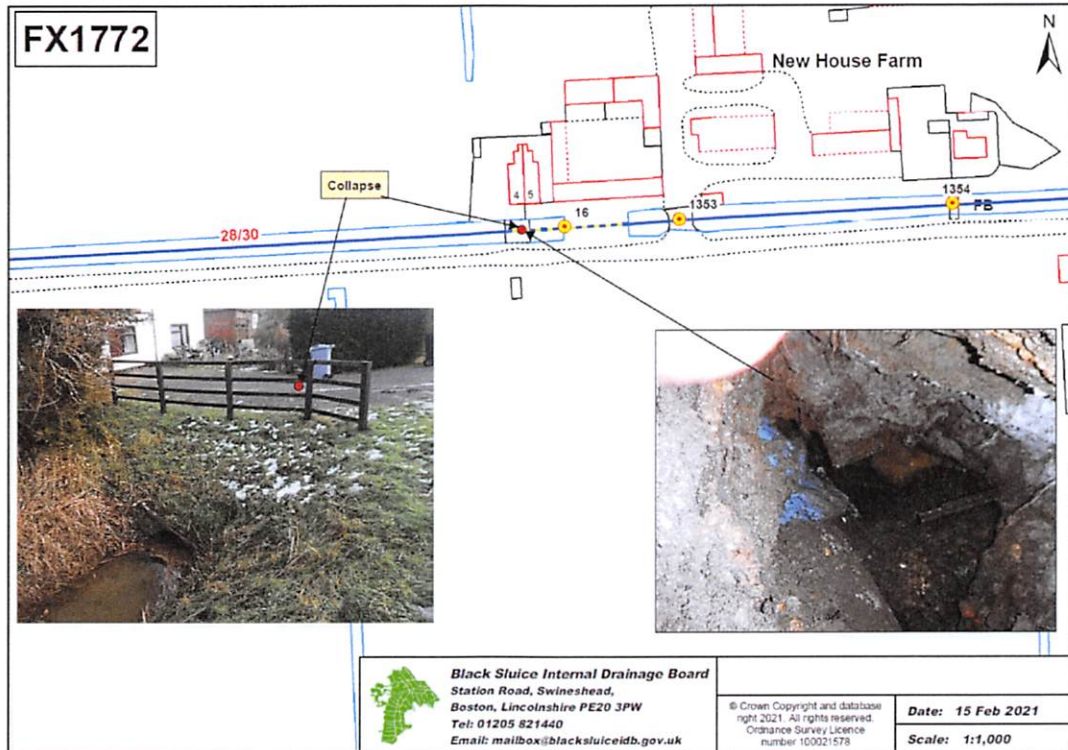
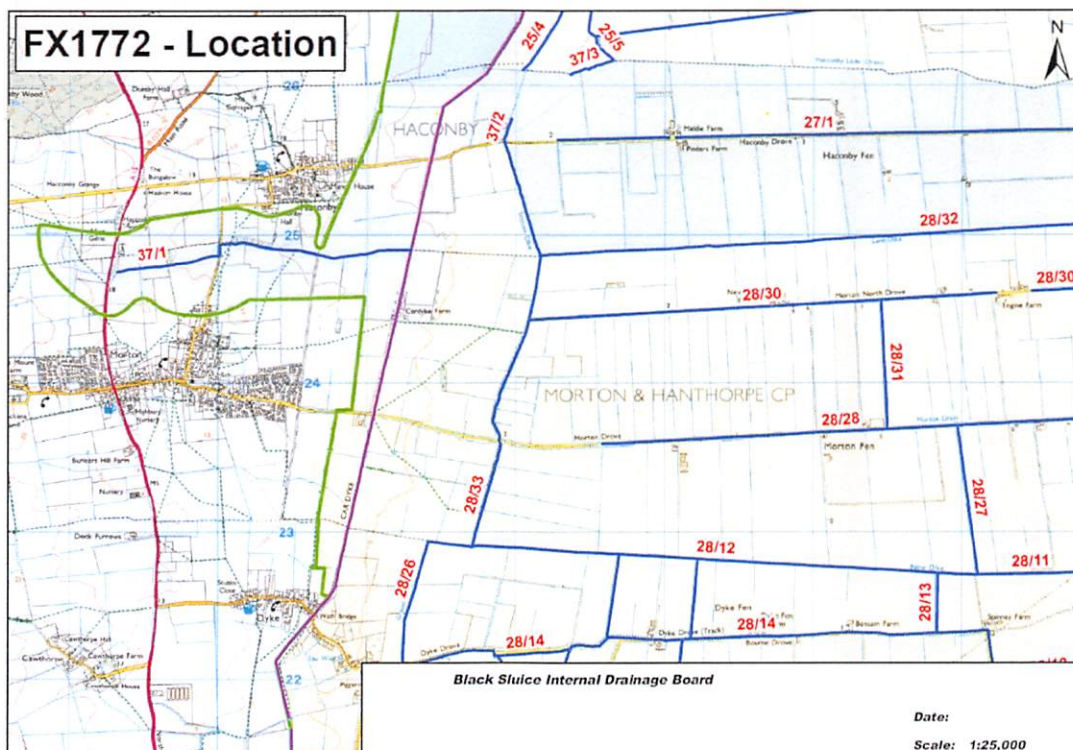
(b) Haconby Fen - No 815 - FX1773 - 18m x 1500mm Armco (Field entrance)

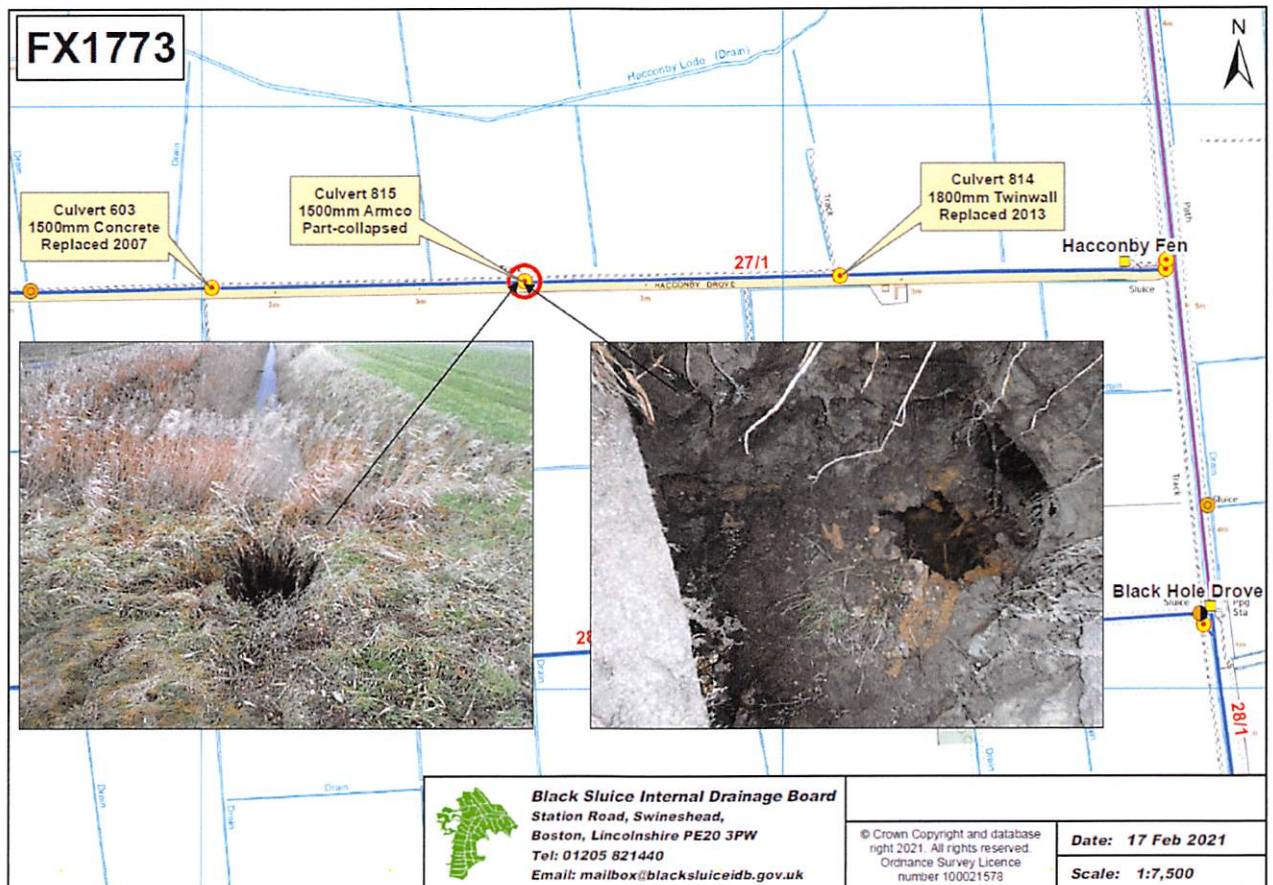
(c) Boston West - No 2757 - FX1764 - 12m x 600mm Armco (Field entrance, close to road)

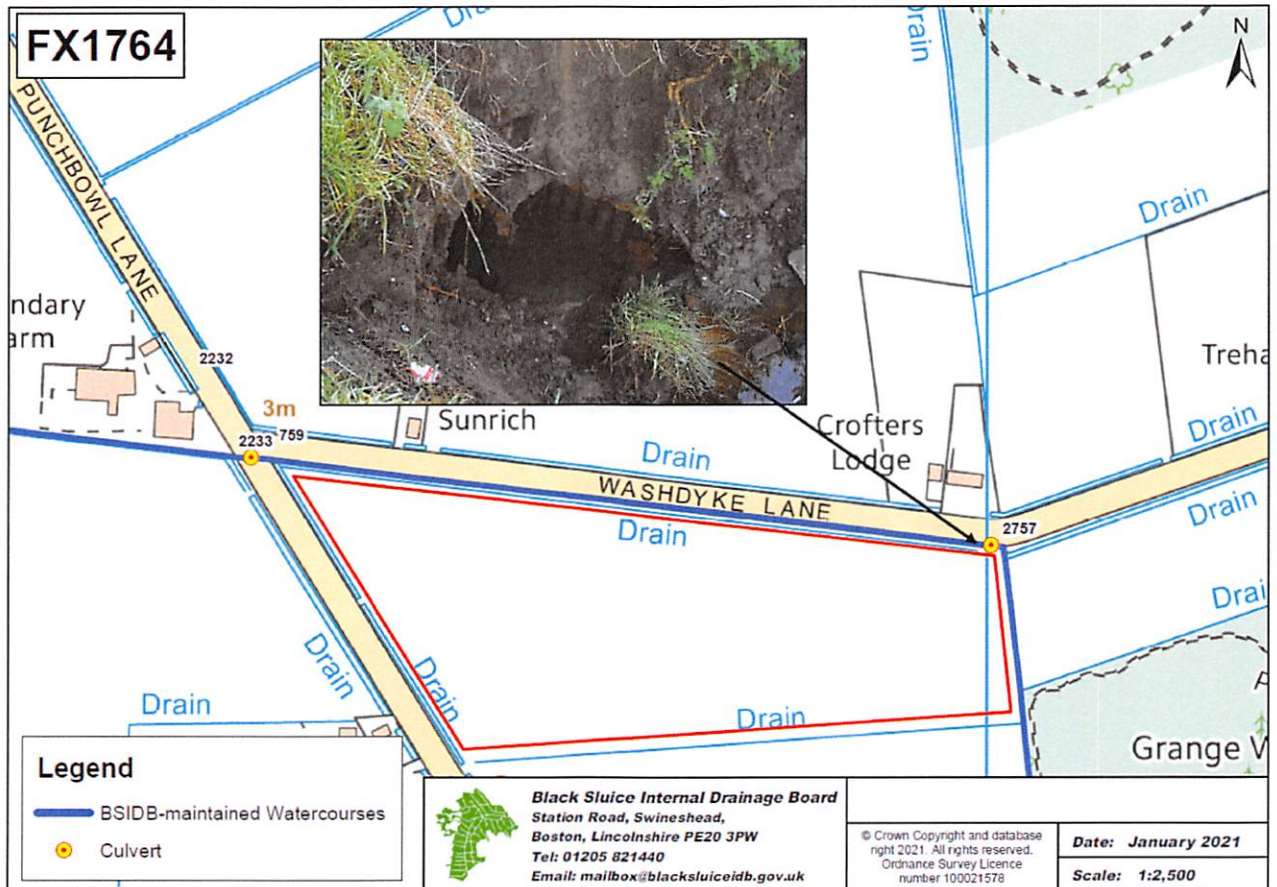
(d) Holland Fen - No 2754 - FX1775 - 8m x 900mm Concrete Ogee (Field entrance)

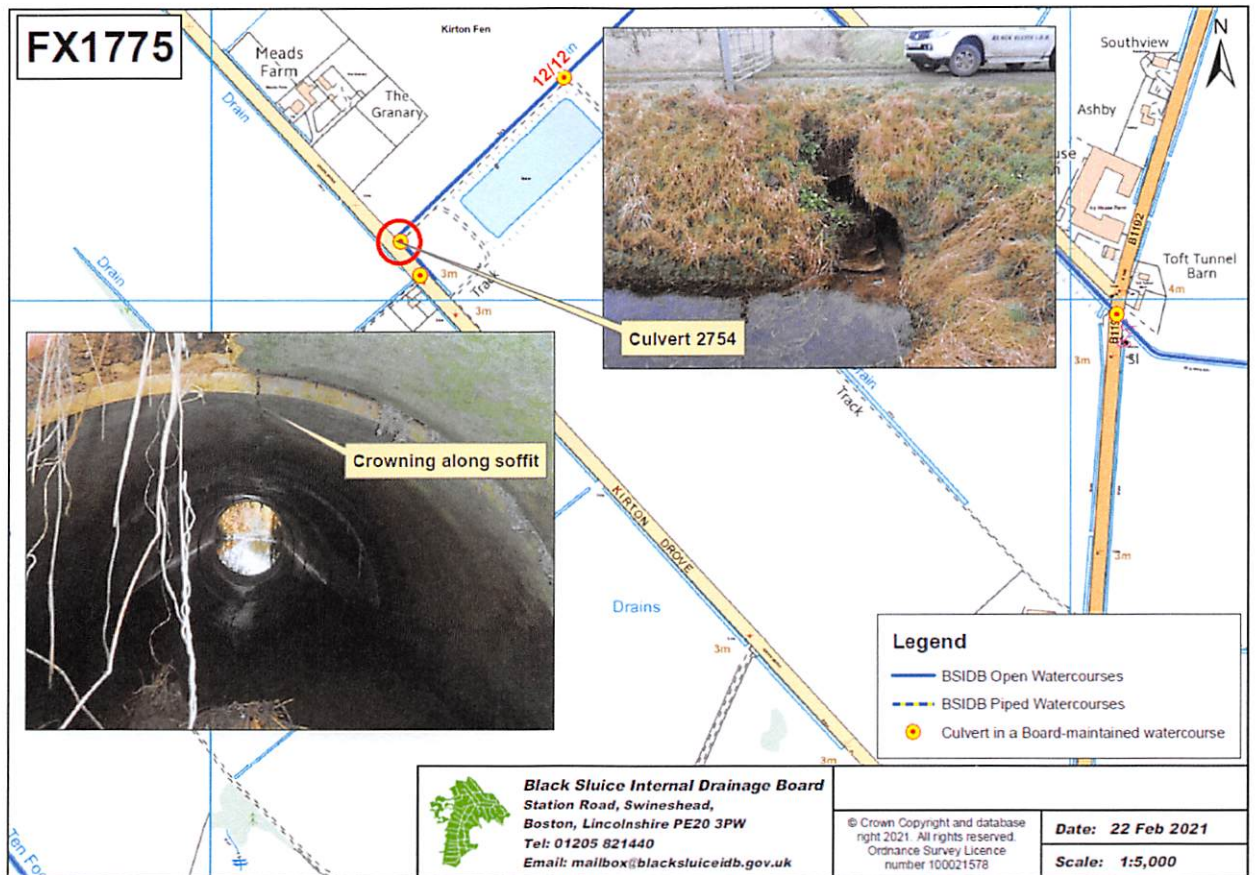
(e) Bicker Fen - No 1408 - FX1770 - 12m x 900mm Armco (Field entrance)

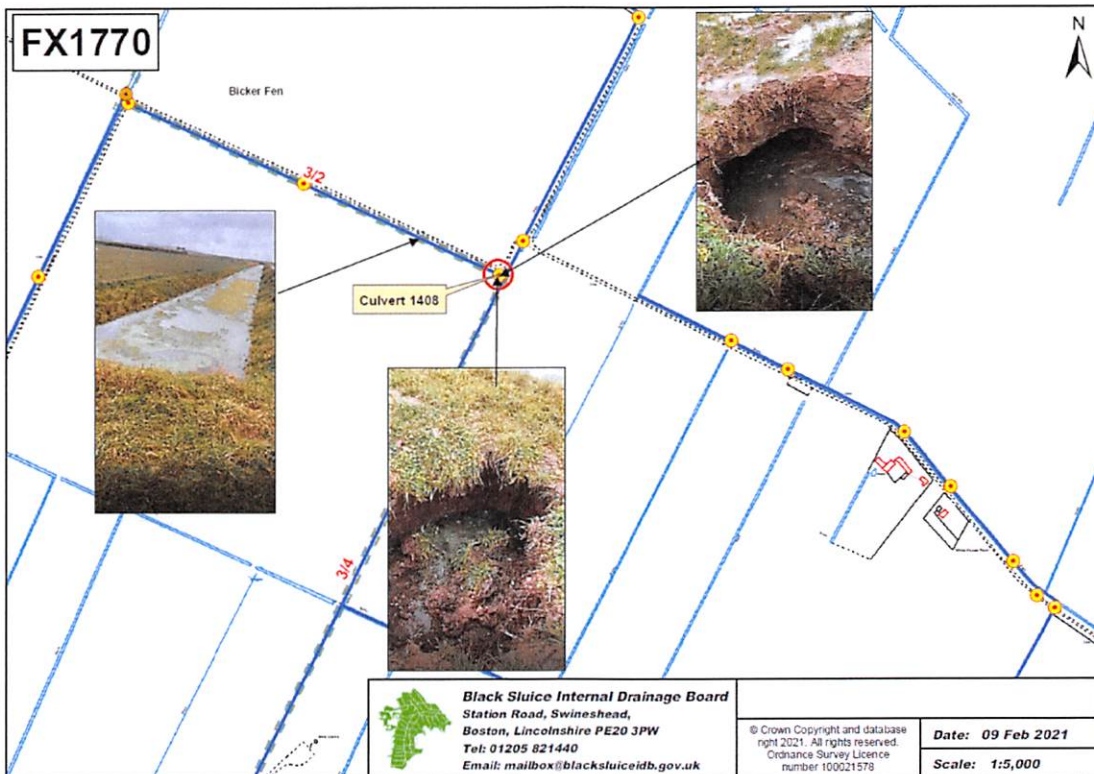
(f) Bicker Fen - No 1469 - FX1769 - 18m x 1200mm Armco (Farm track Field entrance)

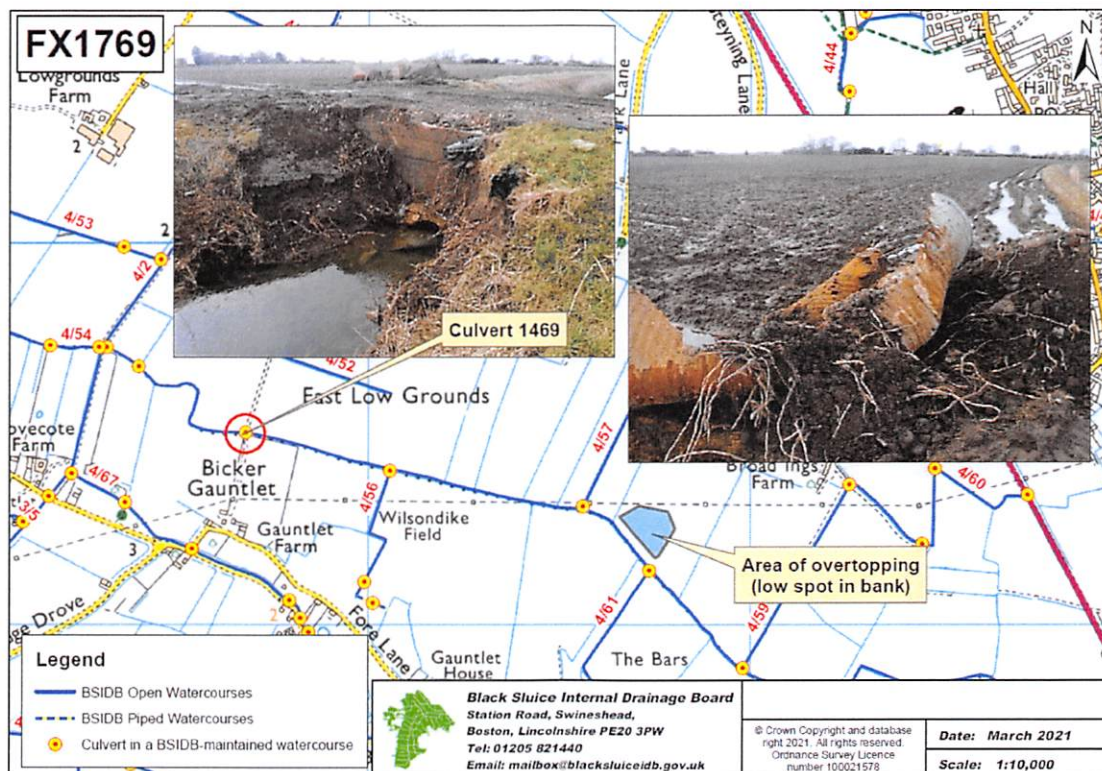
(g) Small Drove - No 718 - FX1760 - 18m x 900mm Armco

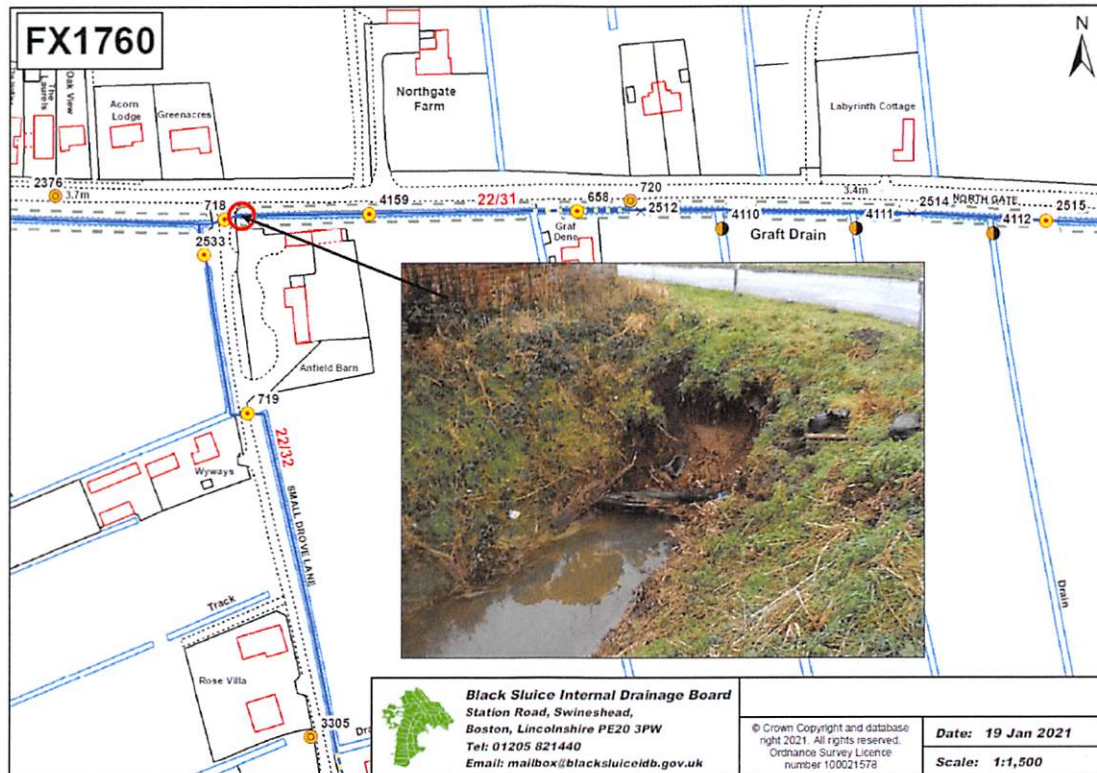
(h) Quadring Fen – No 50 – FX1761 - 18m x 1200mm Armco

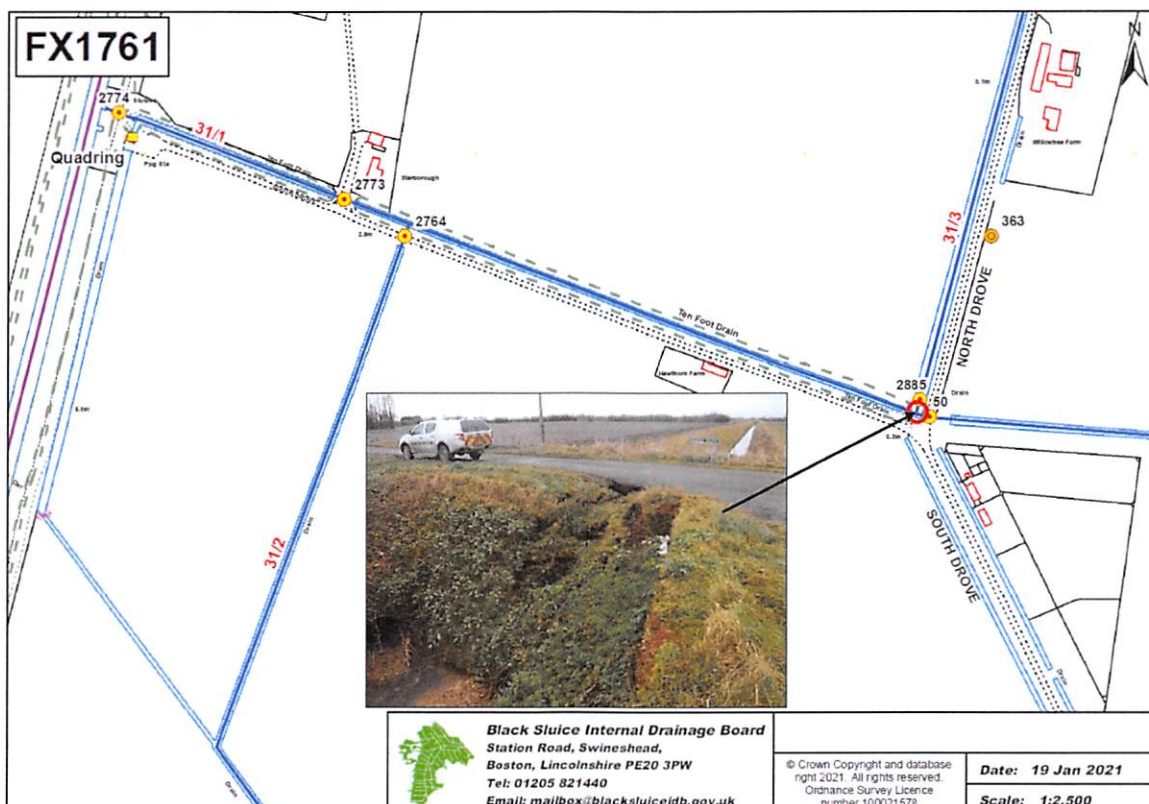
Notified that the headwall of this culvert had failed. Site visit and photos taken. Culvert under road LCC notified. Some remedial headwall repair works completed by LCC, due to the urgency, and concern of road collapse. Ongoing discussion with LCC on these works.

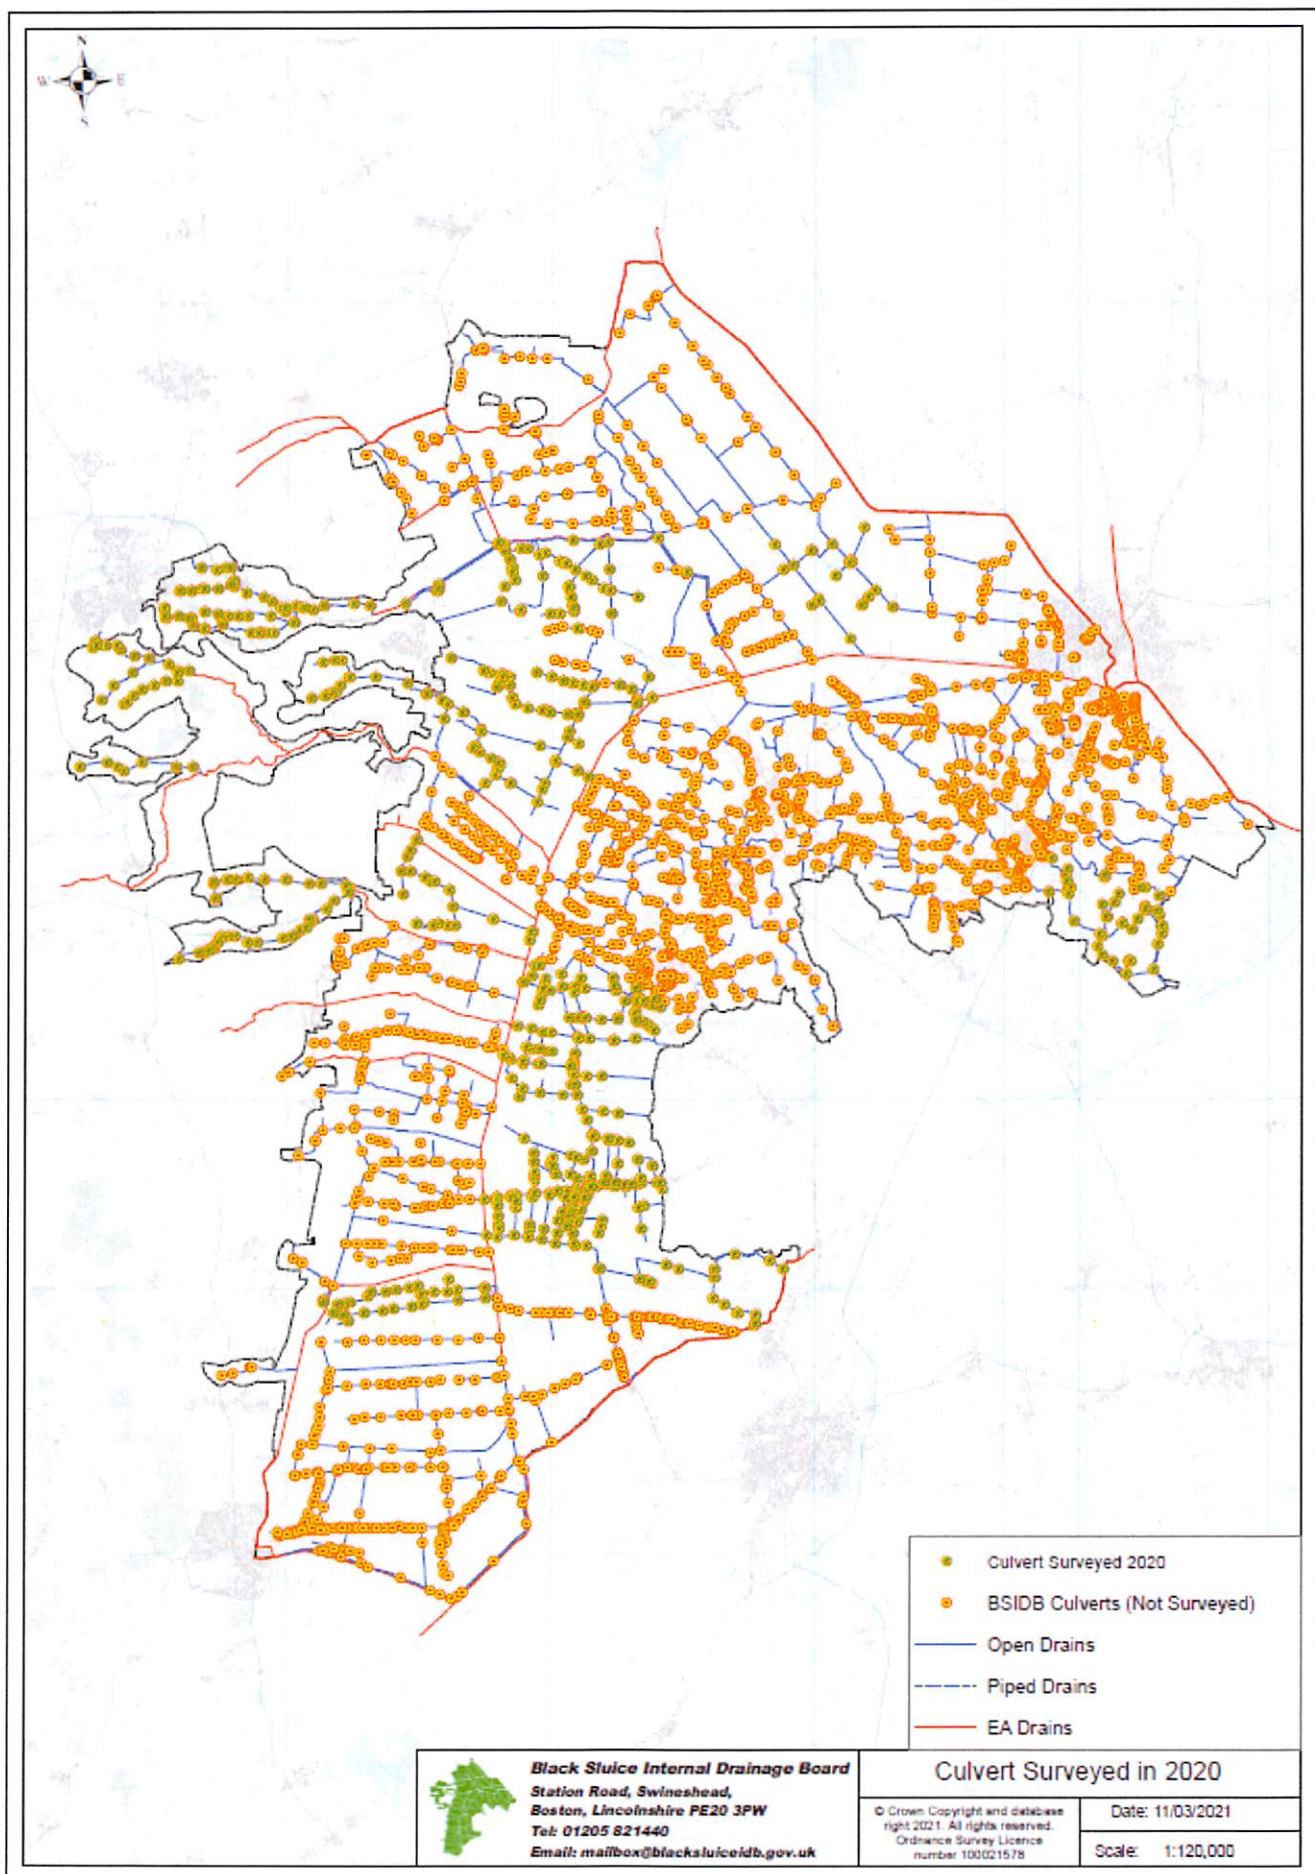
5. Structures Replacement Programme 2021/22

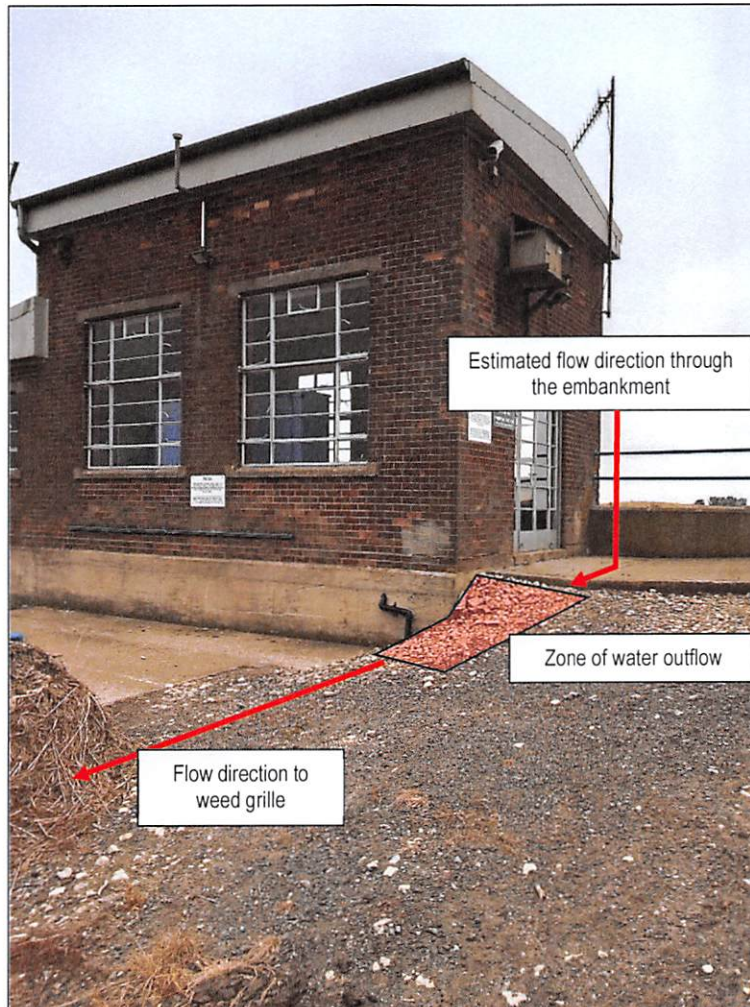
Photograph 1 Approximate seepage beneath the pumping station towards weed grille (photo taken from the north – looking south)

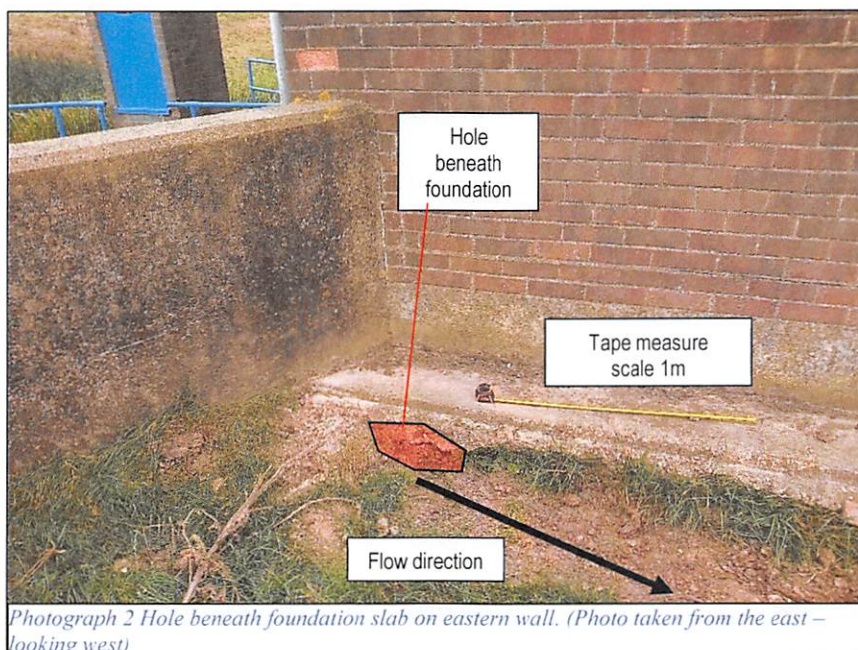
Photograph 2 Hole beneath foundation slab on eastern wall. (Photo taken from the east – looking west)

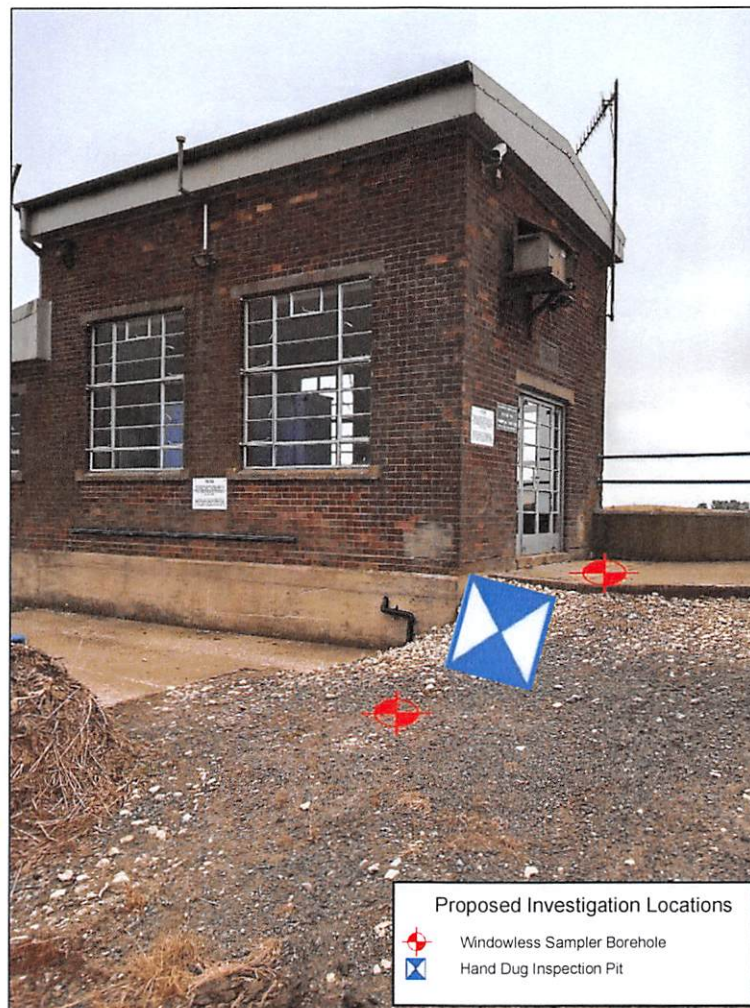
Photograph 2 Proposed exploratory hole locations- western side.

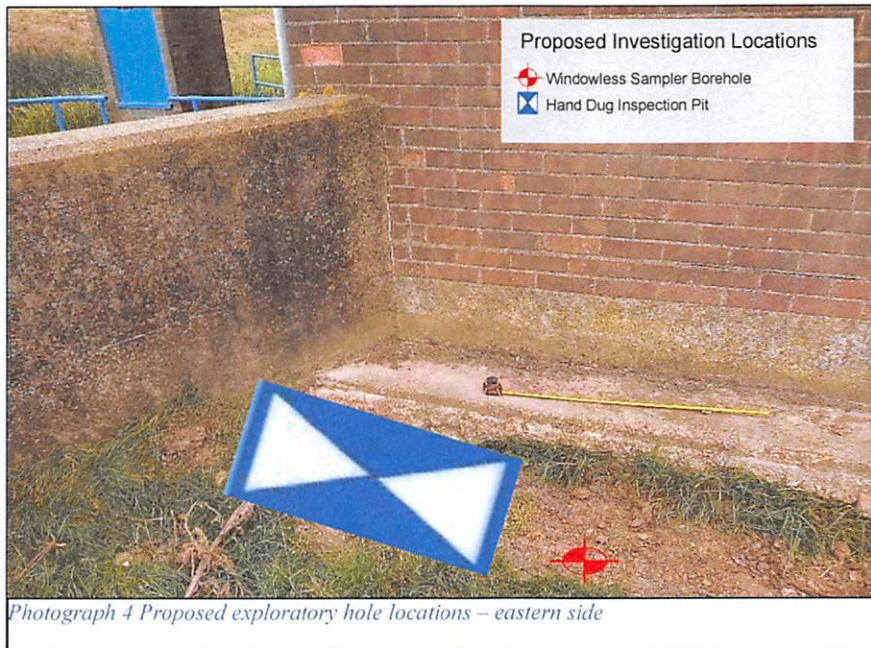
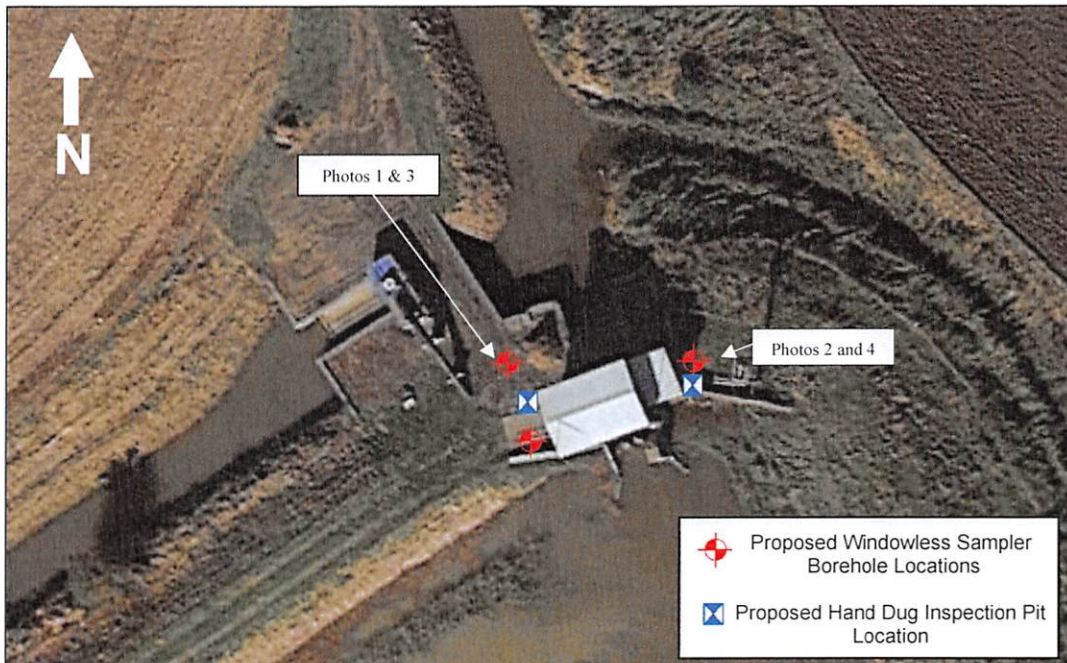
Photograph 5 Proposed investigation location plan

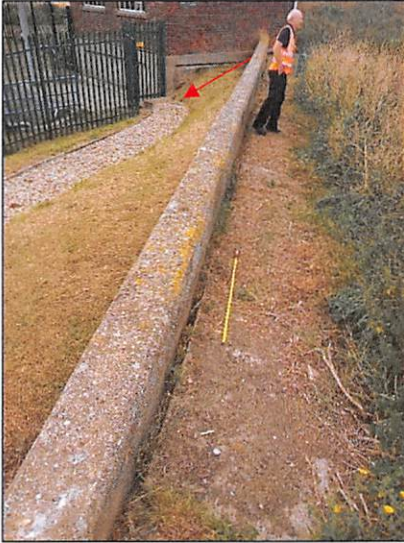
Photograph 1 - Cracking parallel to the concrete retaining/wing wall. Indicating settlement of the soils to the south (right of photo) of the wall. Taken from the west side of the pumping station, looking east

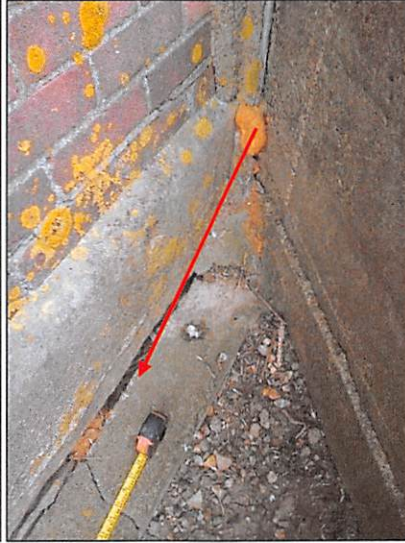
Photograph 2 Cracking between the pumping station building and the retaining/wing wall. Expanding foam used as a temporary measure to infill the crack

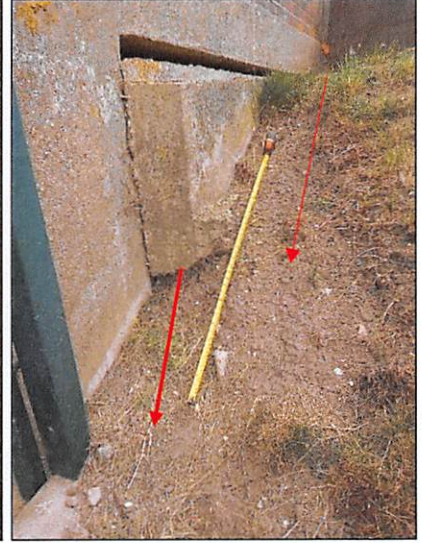
Photograph 3 Exposed and displaced foundation slab beneath the pumping station building, indicating settlement of the underlying soils

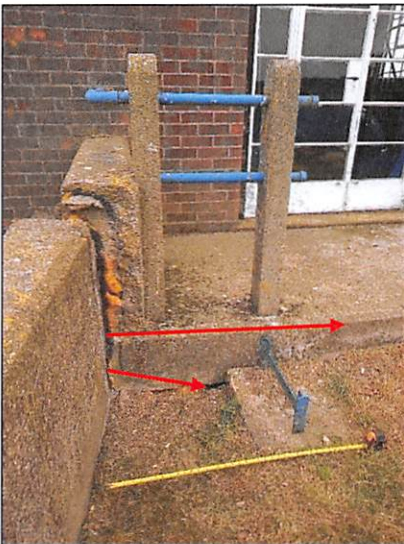
Photograph 4 Displaced retaining/wing wall and settlement beneath concrete slab. Photograph from the eastern side of the pumping station looking westwards

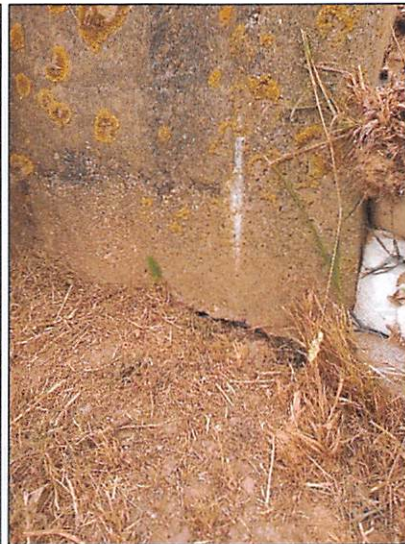
Photograph 5 Settlement of soils beneath the pumping station building foundation

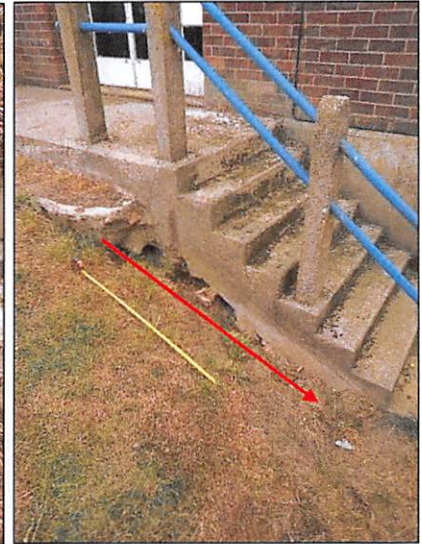
Photograph 6 Settlement of the soils beneath the stairway leading into the pumping station building. Photograph taken from the eastern side of the building looking westwards

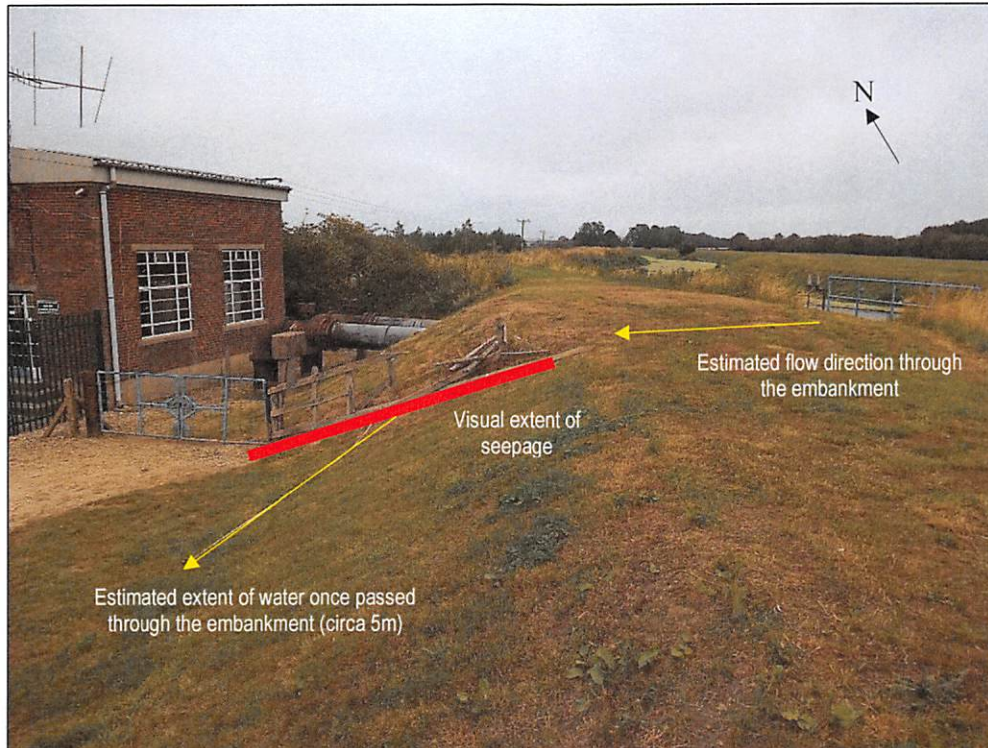
Photograph 1- Approximate zone of seepage – (taken from the toe of the embankment, south of the pumping station, looking north-eastwards along its alignment)

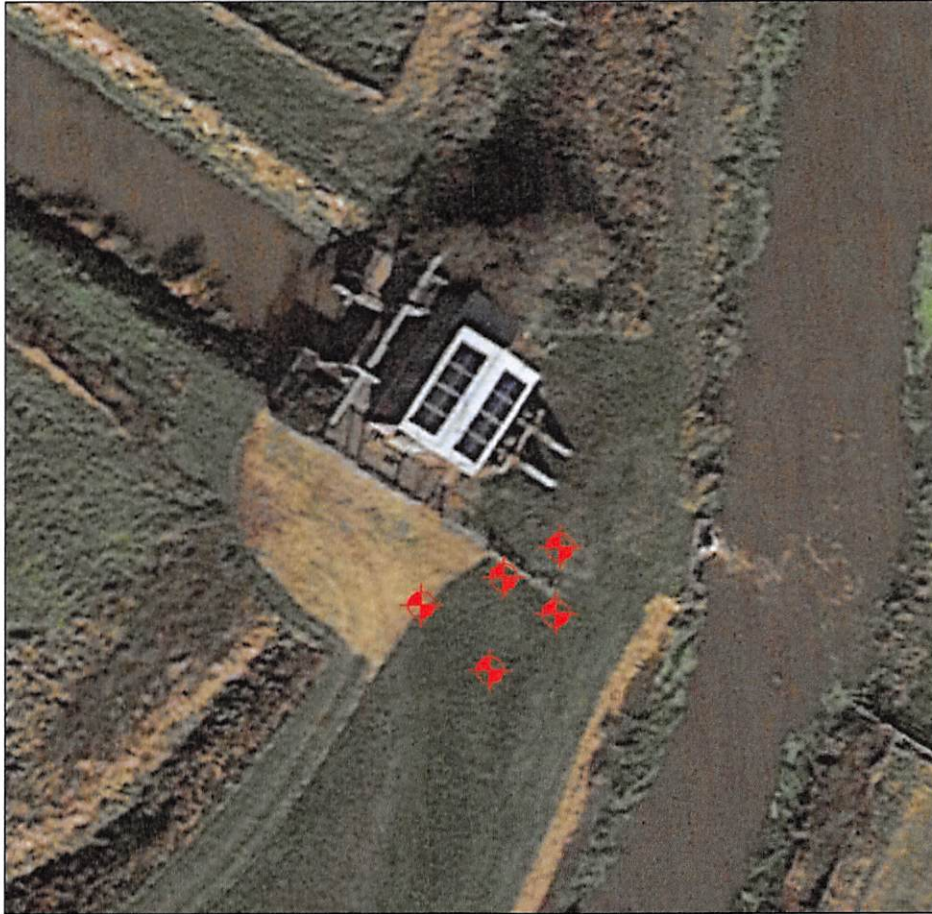
Photograph 3 - Proposed exploratory hole locations
