BLACK SLUICE

INTERNAL DRAINAGE BOARD

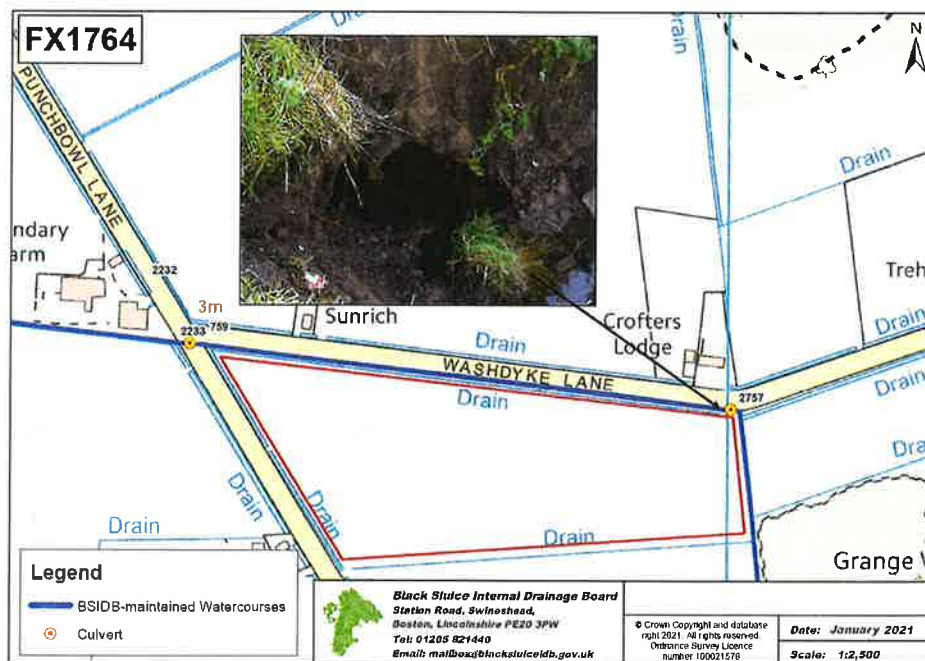
(b) Bicker Fen - No 1469 - FX1769 - 18m x 1200mm Armco (Farm track Field entrance)

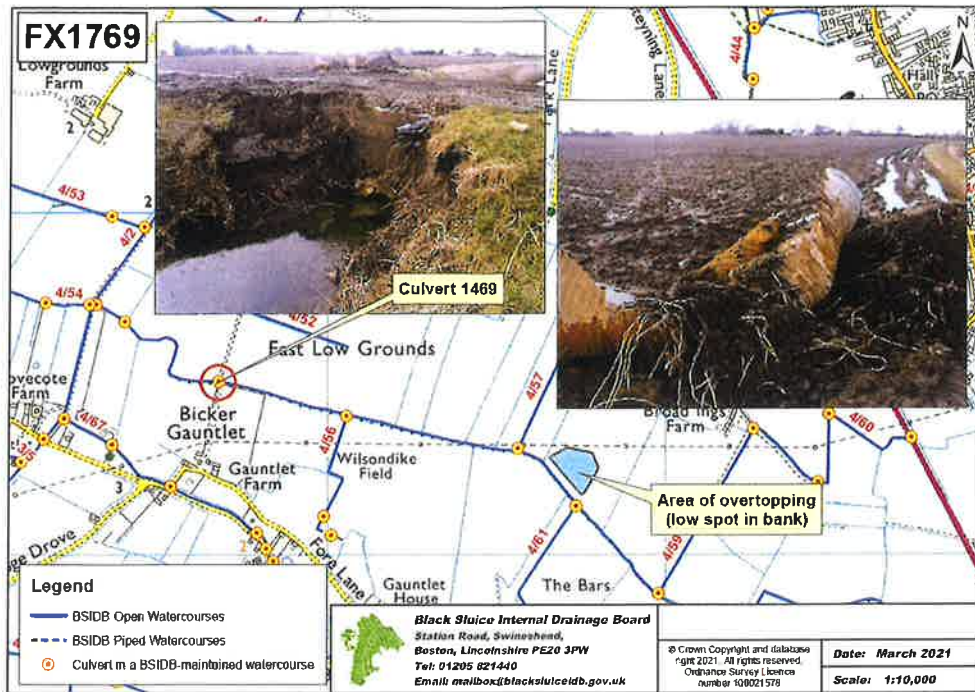
(ii) Culvert Surveys Reports

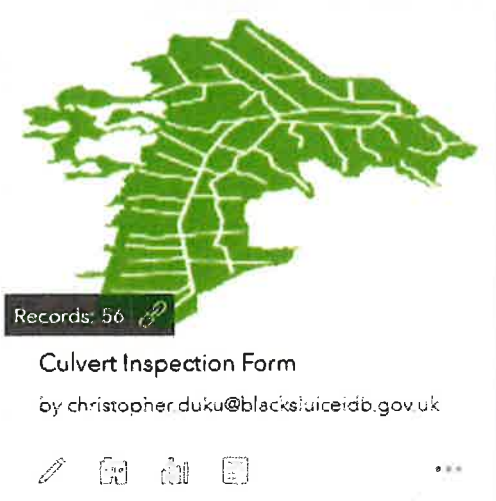
Culvert Survey reports
Information on culvert surveys completed in 2021/22

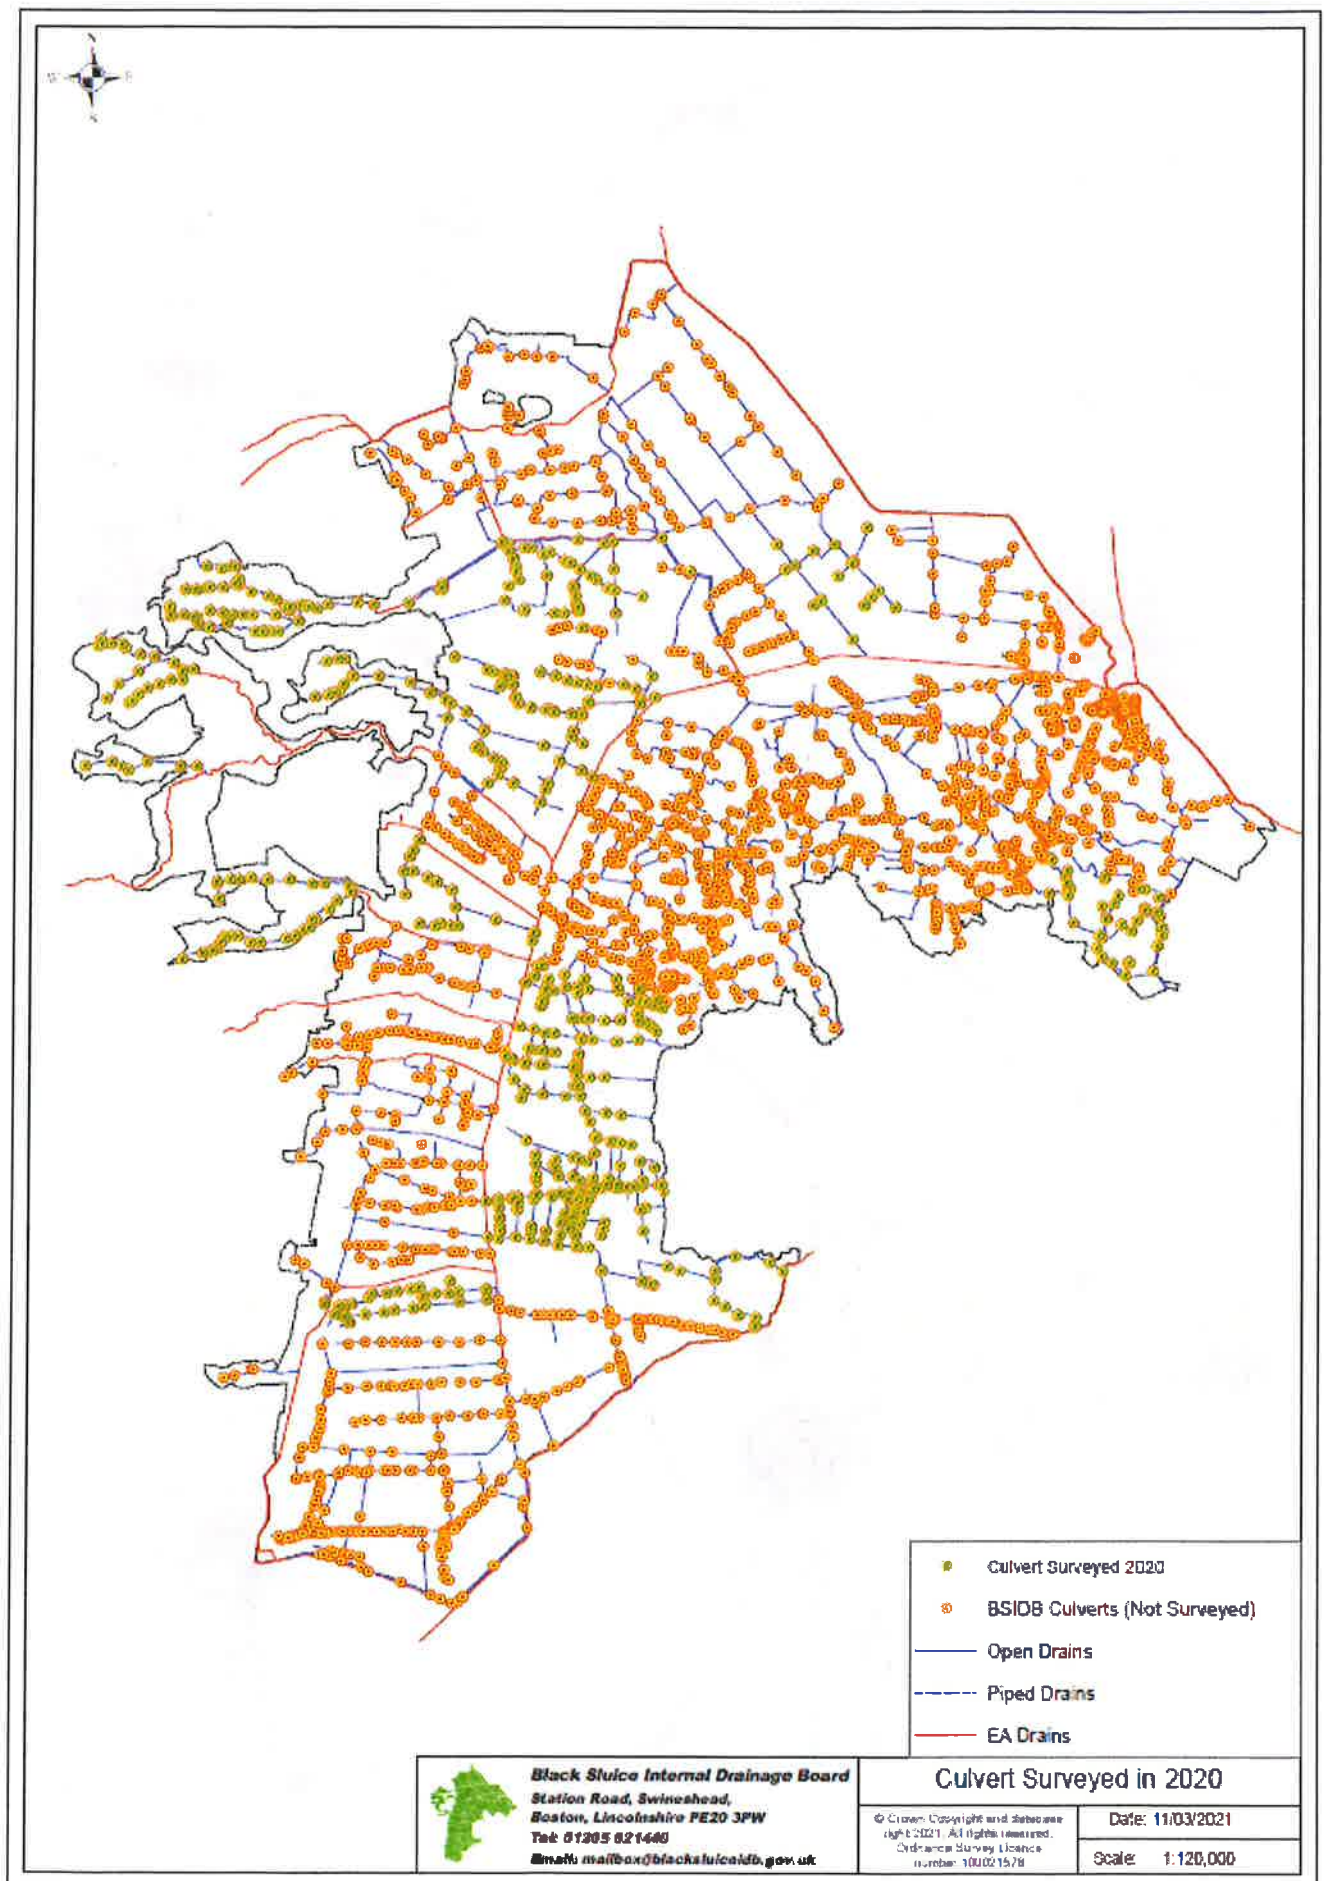
(iii) Culverts reported in a poor condition

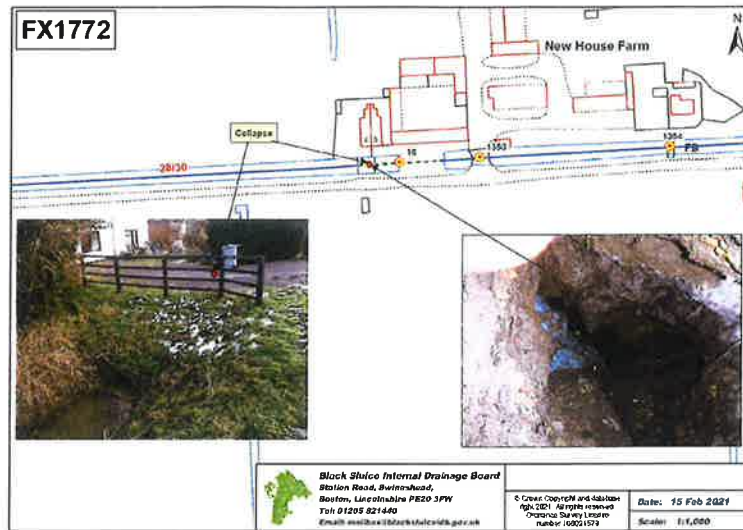
Following correspondence on this matter with the landowner the Operations Manager had a site meeting in December 2021 to discuss a way forward with the collapsed culvert at this site. An estimate of £30,000+ was provided to replace the existing 30m x 900mm culvert as a visual inspection of the pipe from both ends shows corrosion along the water line. The partial collapse of the culvert is not currently impeding flows. It was at this meeting that the proposed development of the site was discussed, whereby it was stated that the proposal would have to be approved by the Board following an application.

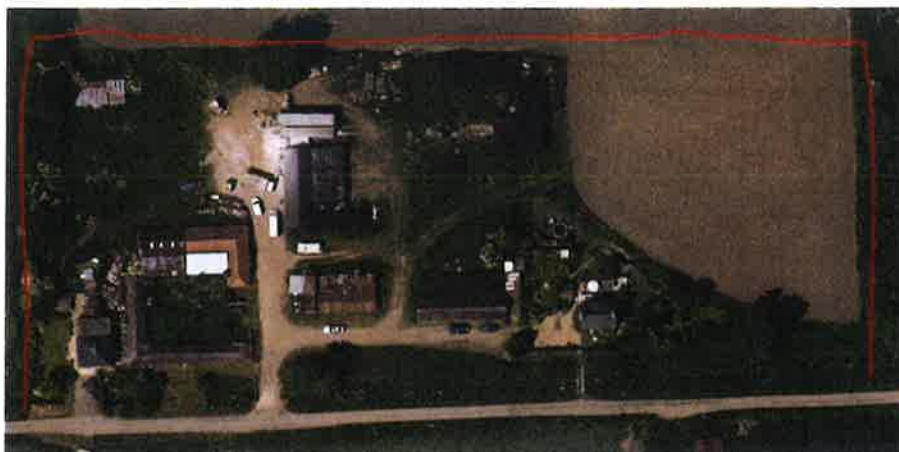
The landowner has since asked if the Board would consider rerouting the drain around the properties along the line shown below, along with an email (included below).

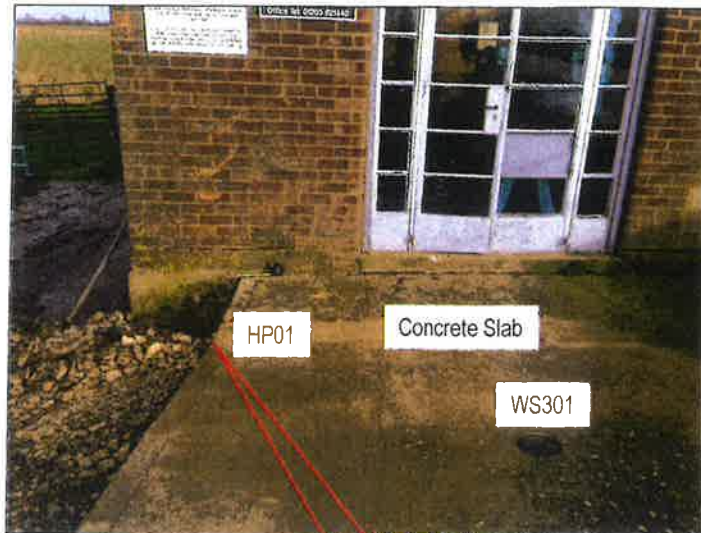
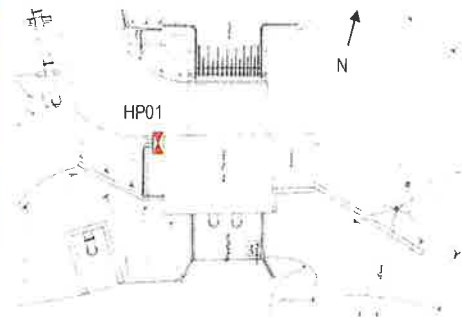
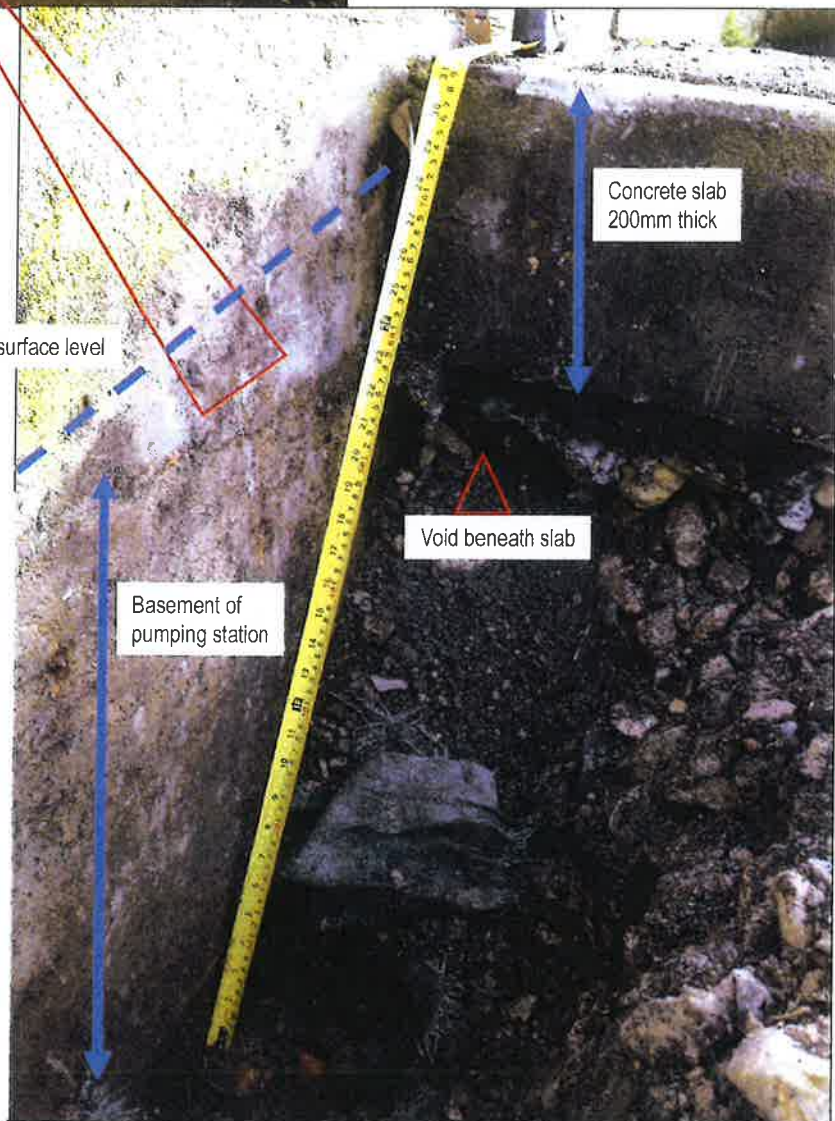
See hand pit logs for further details of encountered ground conditions.

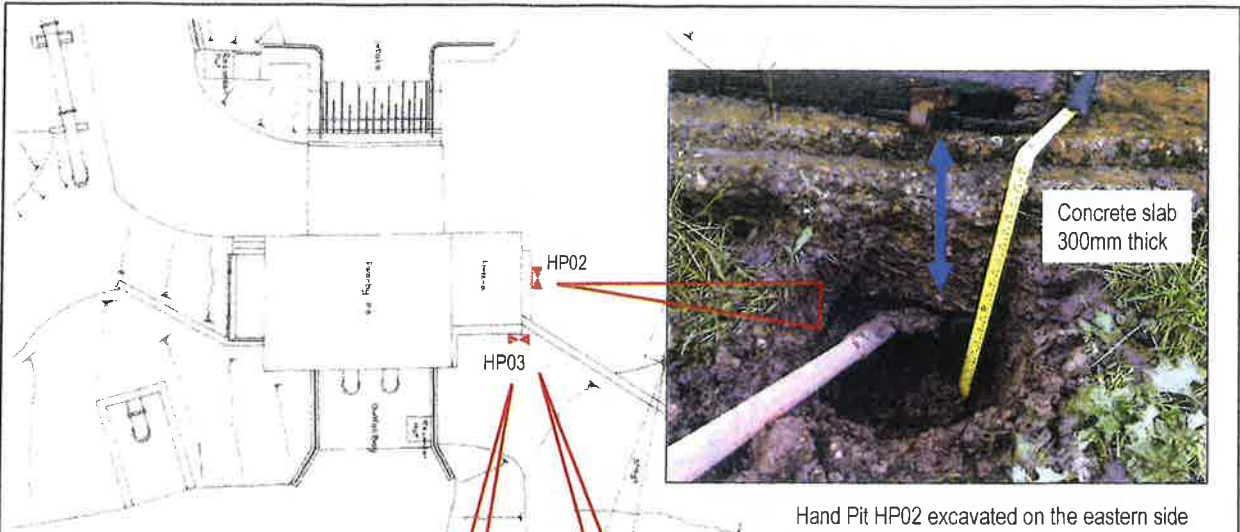
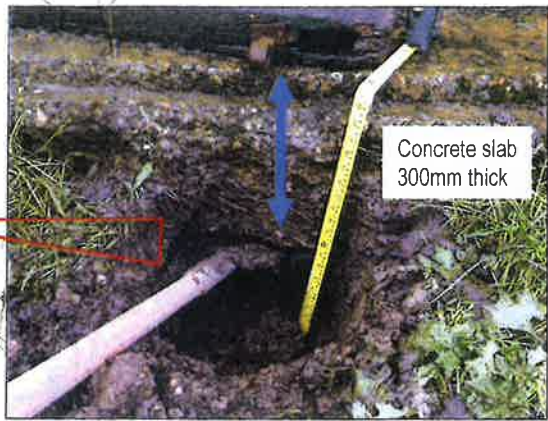
Hand Pit HP02 excavated on the eastern side of the pumping station/annex building. Hand pit terminated upon encountering pile foundation beneath capping beam/slab.

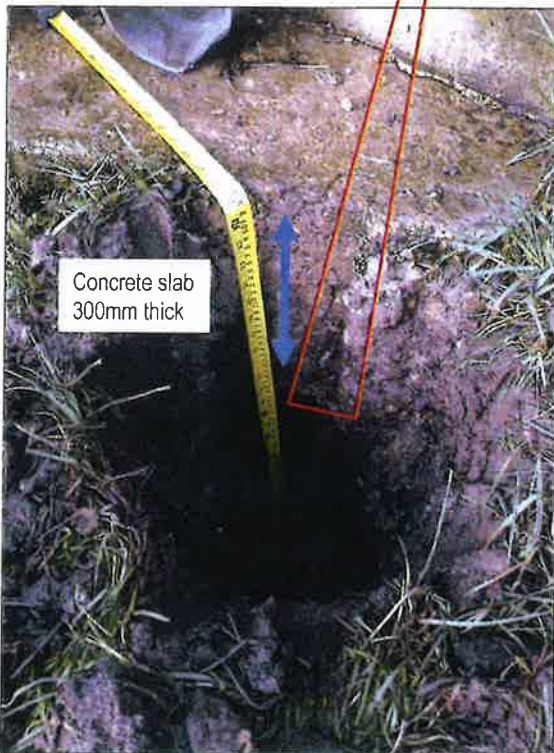
Hand Pit HP03 excavated on the southern (highwater) side of the pumping station/annex building. Hand pit terminated upon encountering pile foundation beneath capping beam/slab.

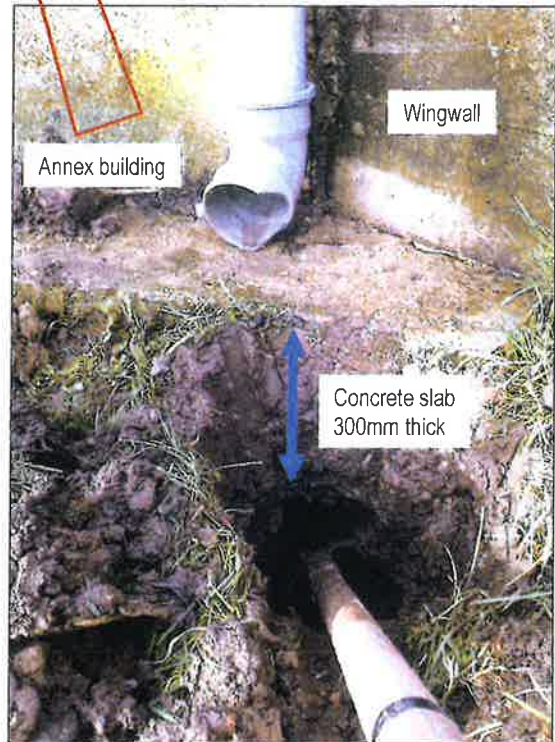
See hand pit logs for further details of encountered ground conditions.

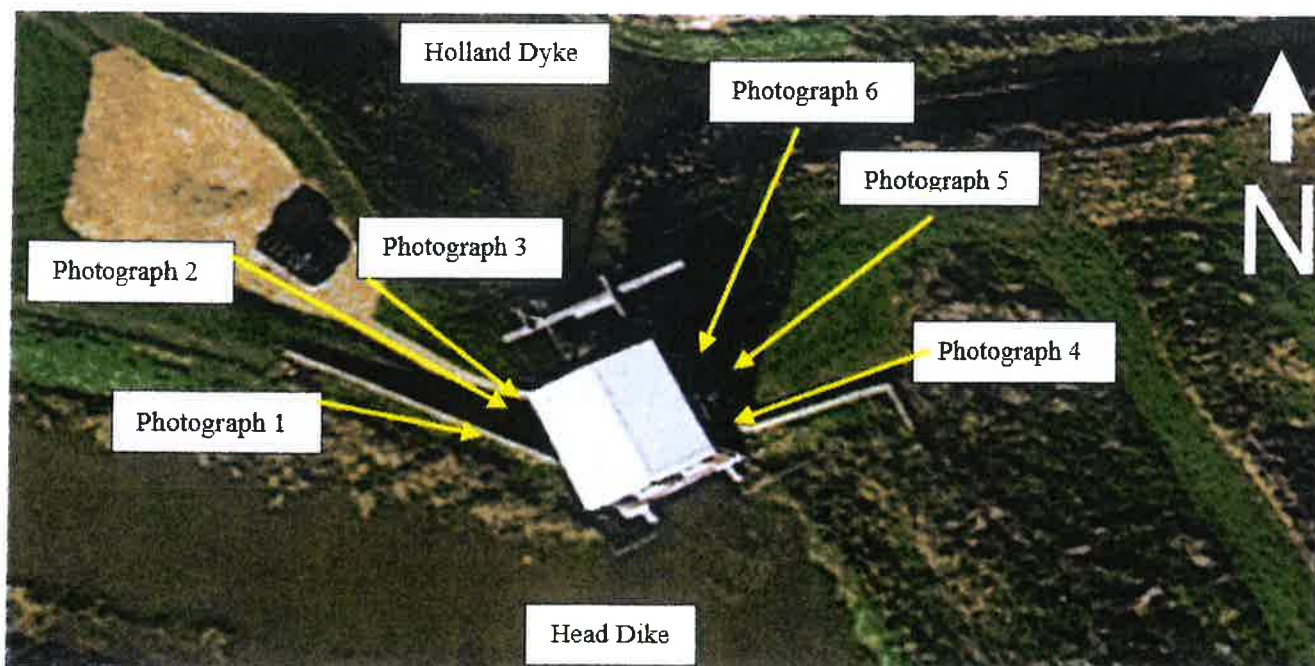
A construction drawing shared by the client (see **Appendix A**) shows the substructure of the pumping station. The station is founded on driven precast concrete piles and steel sheet piles. The landings at the top and bottom of the

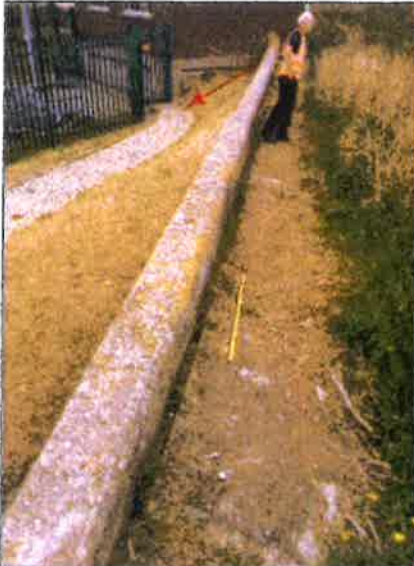
Photograph 1 - Cracking parallel to the flood wall. Indicating settlement of the soils southward (right of photo) of the wall.

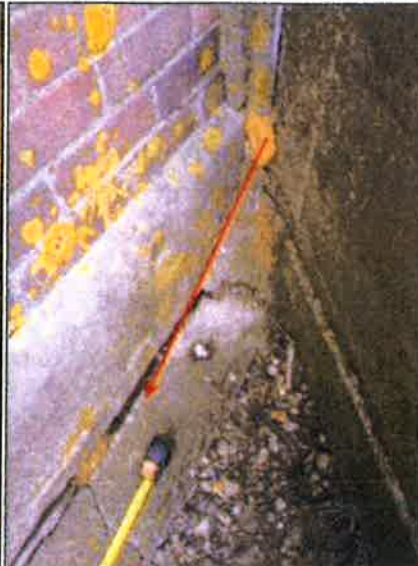
Photograph 2 - Cracking between the pumping station building and the flood wall. Expanding foam used as a temporary measure to infill the crack.

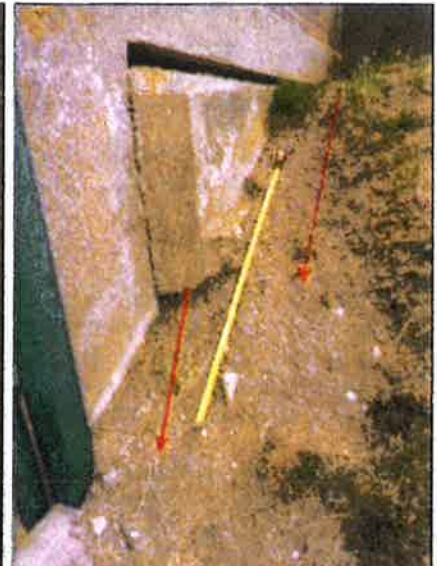
Photograph 3 - Exposed and displaced foundation slab beneath the pumping station building, indicating settlement of the underlying soils

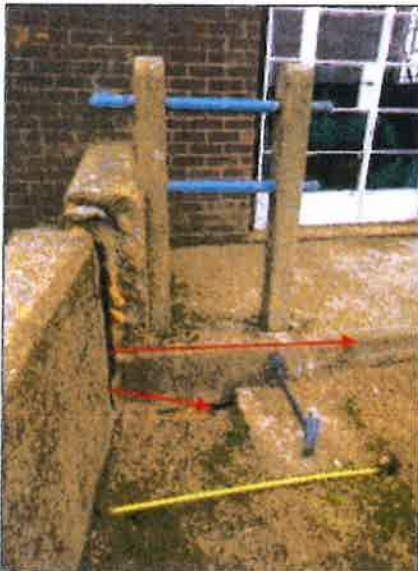
Photograph 4 - Displaced flood wall and settlement beneath concrete slab

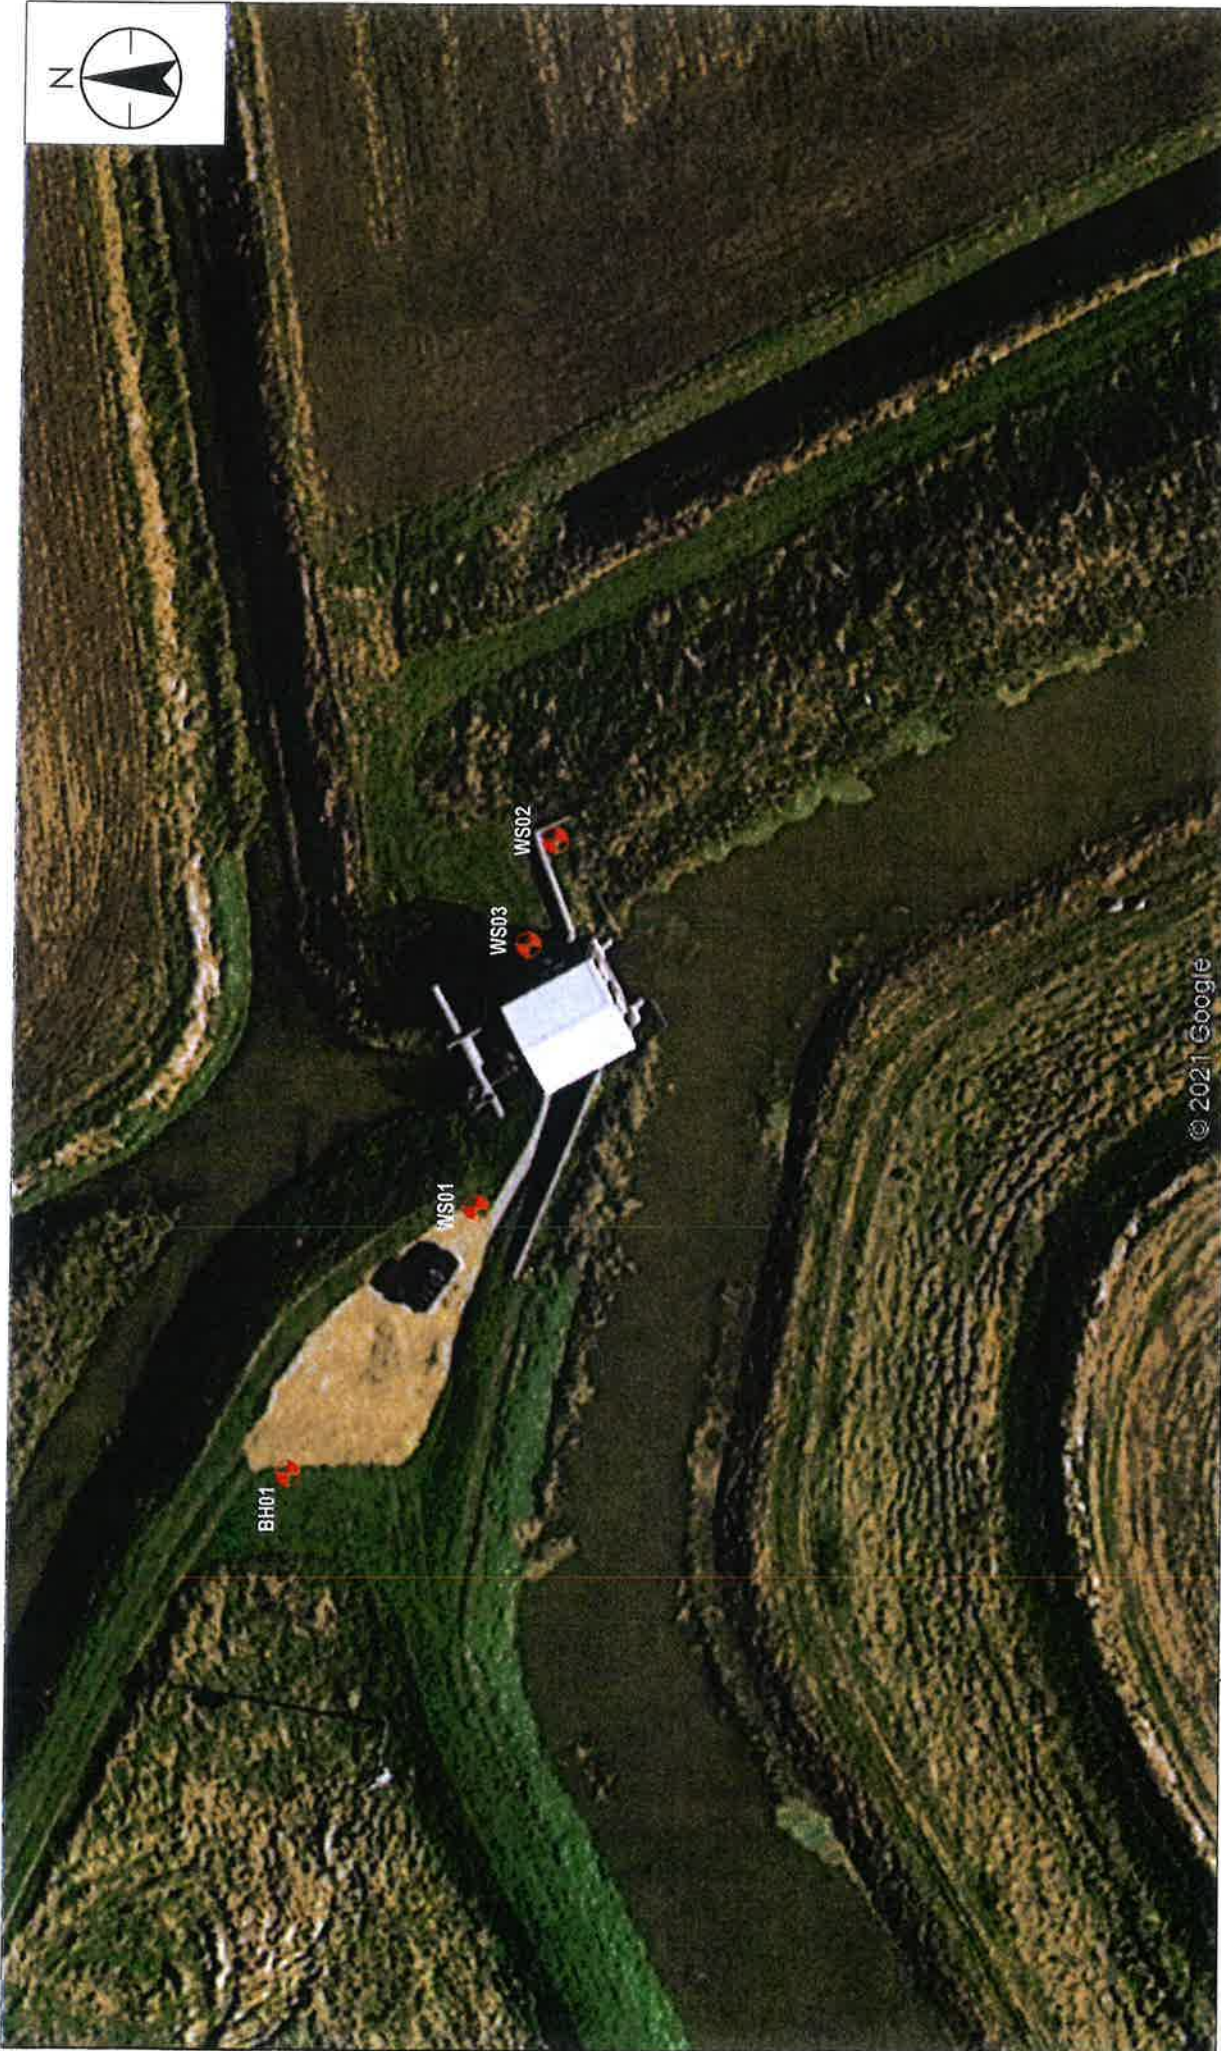
In the case of the seepage beneath the eastern side of the pumping station it will be necessary to block the flow of water through the ground and this may be possible by reducing the permeability of the soil locally. This could be achieved by excavation and replacement with well compacted high plasticity clay fill that would provide a low permeability barrier to the flow of water. If compaction of clay fill would be too difficult to achieve in the restricted space, then consideration could be given to filling the void created by removal of the material with a bentonite slurry which does not require compaction.

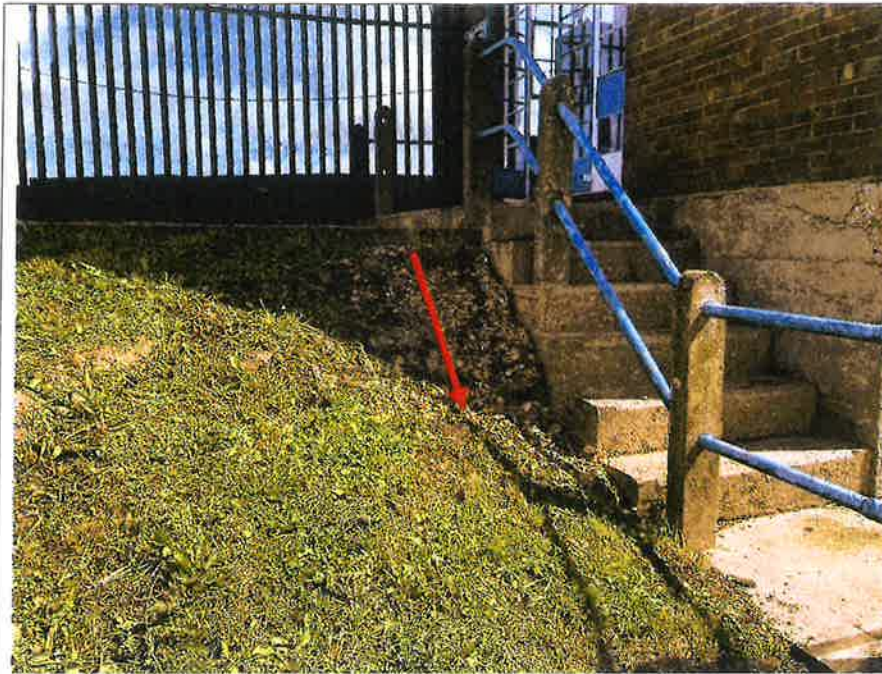
Photograph 1 - West side of pumping station. Settlement of the soils beneath the stairs leading into the pumping station building. Photograph taken looking north. Arrow denotes seepage water flow.

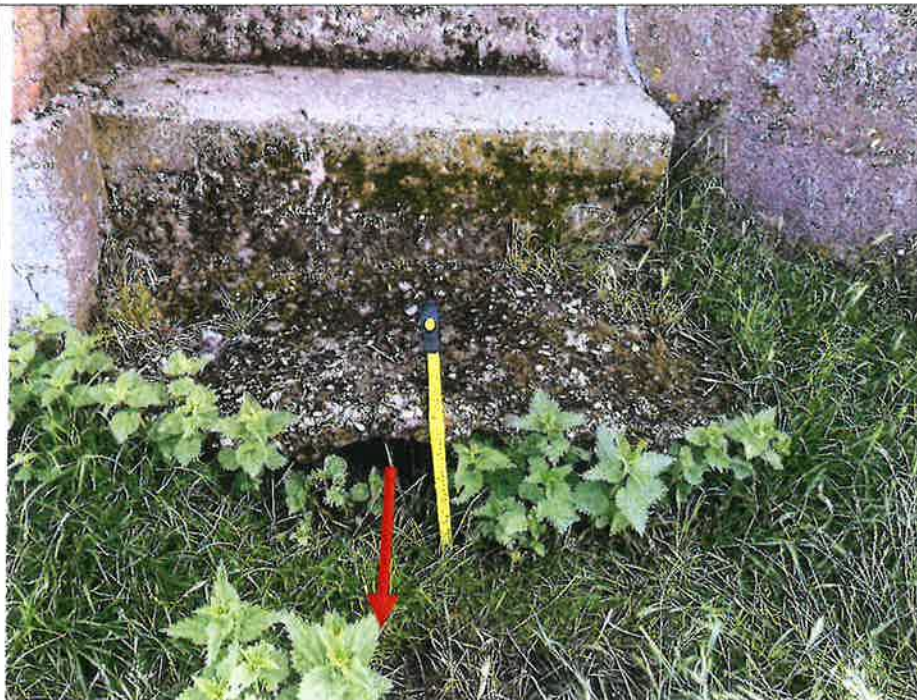
Photograph 2 - A void present beneath the bottom of the concrete steps to the west side of the pumping station as a result of ground settlement. Water has been noted to flow through this void during high water levels. Arrow denotes seepage water flow.

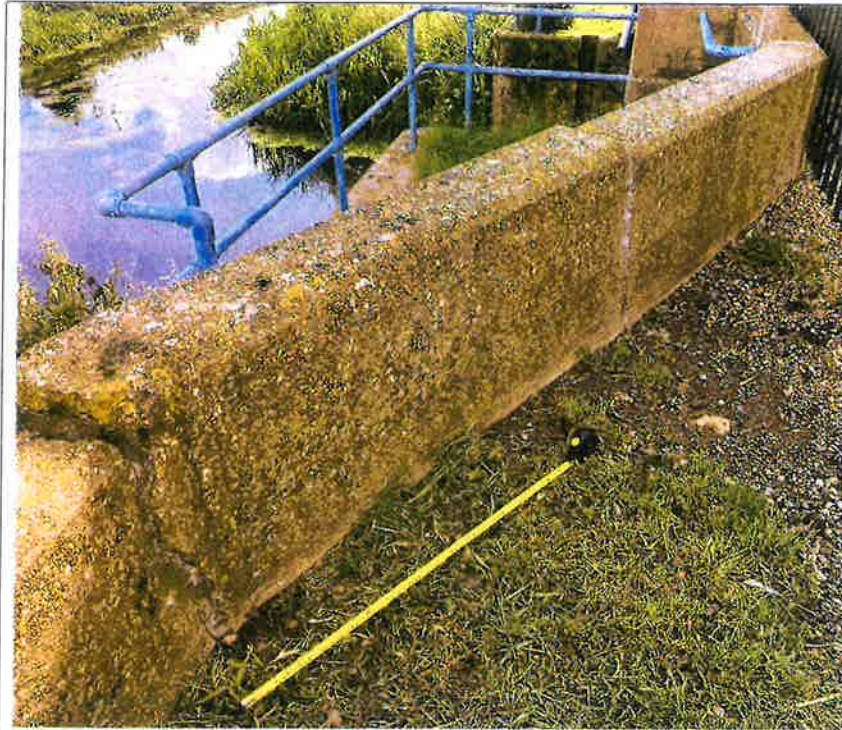
Photograph 3 - Western side of pumping station. Movement and dislocation of the concrete wingwall sections downwards and to the left of view, and evidence of temporary repairs of cracks in the wall. Tape 1m long for scale.

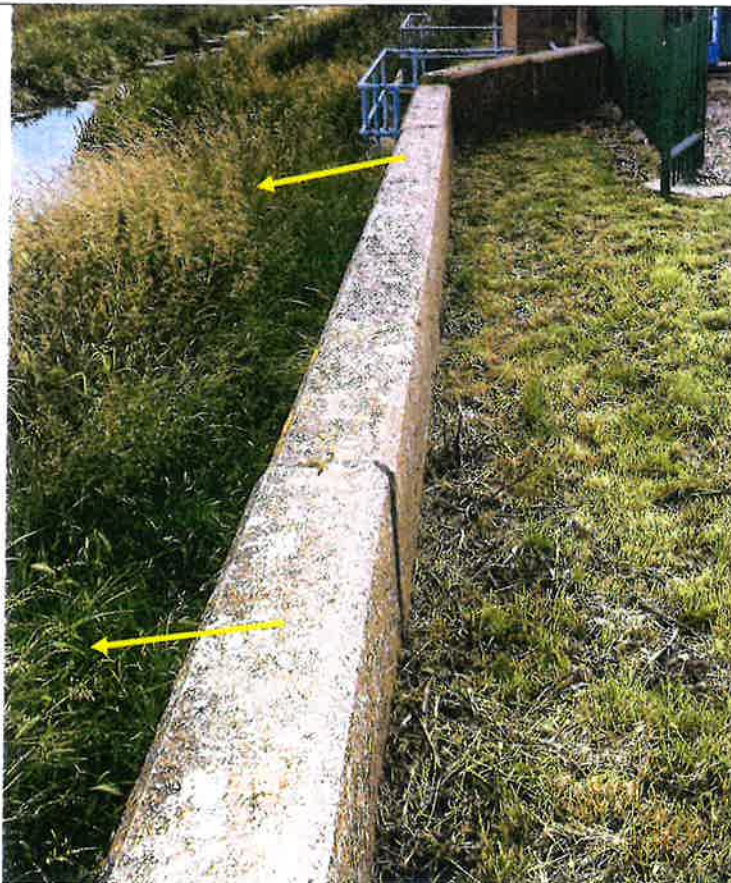
Photograph 4 - Western side of pumping station. Settlement of soils on the northern side of the wingwall. Yellow arrows show indicate rotation of the concrete sections towards the north.
