BLACK SLUICE

INTERNAL DRAINAGE BOARD

Structures Committee Meeting

Tuesday, 21st March 2023 at 2pm

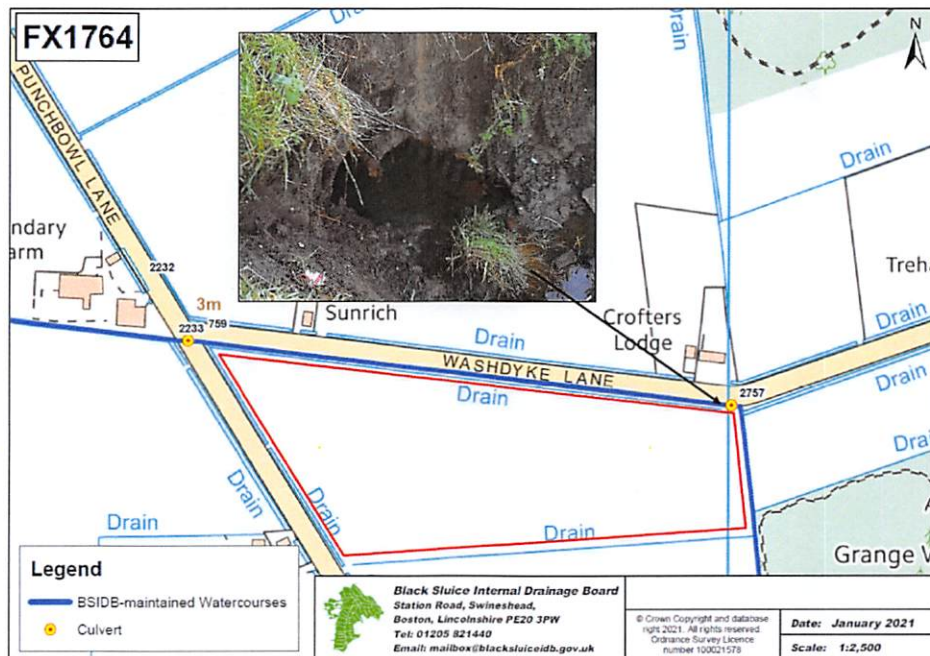
The condition of this culvert is monitored, LCC have been informed about the landowners concerns and the proximity to the highway. The land is tenanted, and the tenant requires the culvert to be replaced.

A contribution may be beneficial and offered towards the replacement of this culvert: £1,000 estimate.

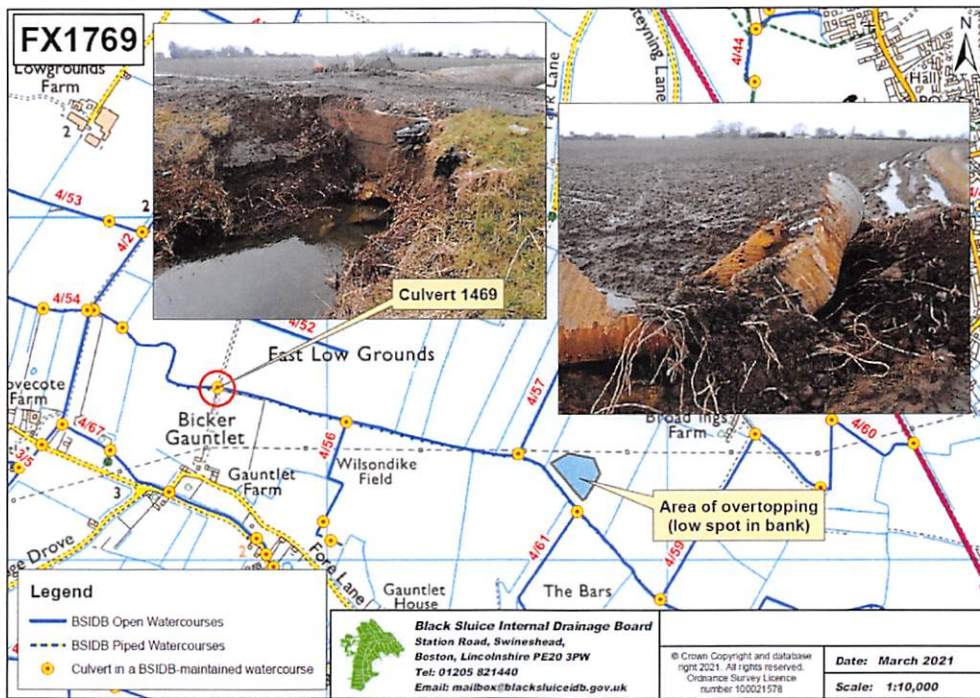
(b) Bicker Fen - No 1469 - FX1769 - 18m x 1200mm Armco (Farm track Field entrance)

This culvert has partially collapsed, the blockage removed by the Board. The Operations Manager has discussed with the landowner about potential replacement.

A contribution may be beneficial and offered towards the replacement of this culvert: £1,000 estimate.

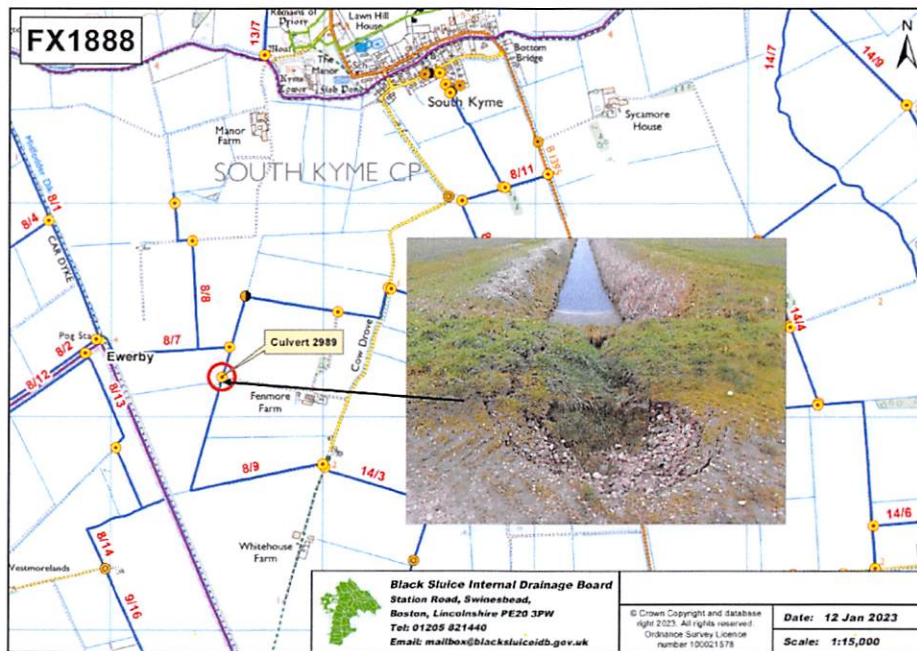
(c) South Kyme Fen – No 2989 – FX1888 – 18m x 1200mm Armco (Field Entrance)

This culvert has partially collapsed, the blockage removed by the Board. The Operations Manager has discussed with the landowner about potential replacement. An estimate of £20,000 was provided to the landowner for the Board to replace this culvert, which was agreed and has now been replaced. A contribution may be beneficial and offered towards the replacement of this culvert: £1,000 estimate.

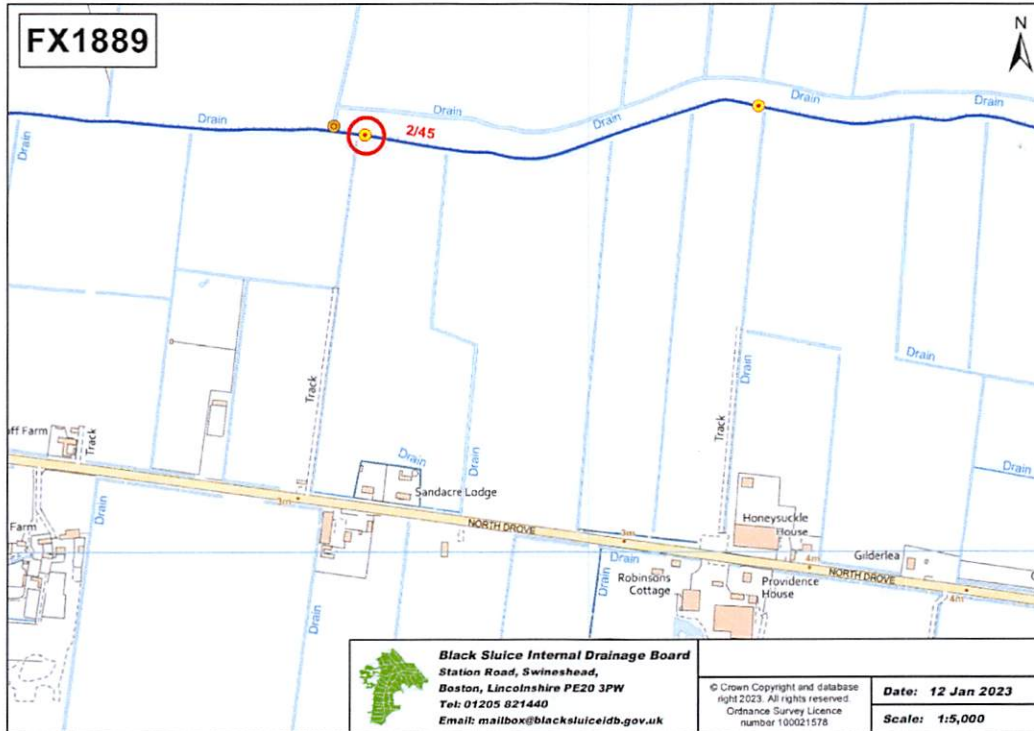
Quadring Fen - No 3353 – FX1889 – 15m x 600mm Armco (Field Entrance)

This culvert has partially collapsed and is being monitored. The Operations Manager has discussed with the landowner about potential replacement.

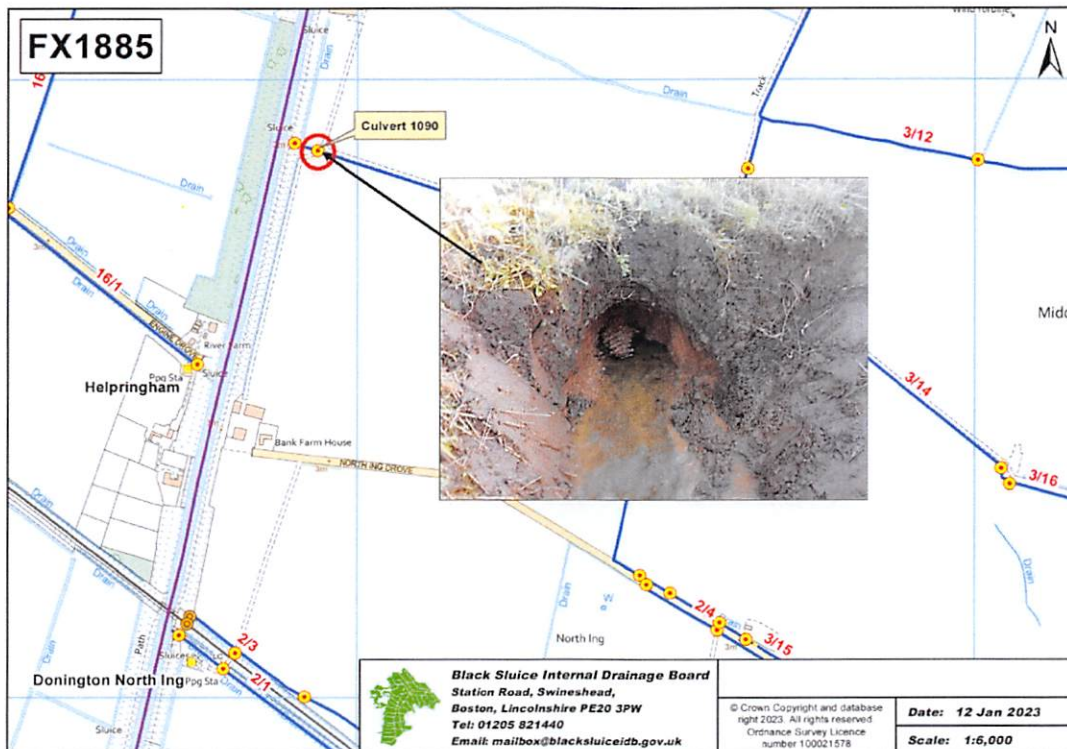
Bicker Fen – No 1090 – FX1885 – 12m x 600mm Armco (Farm track Field access)

This culvert has partially collapsed, the blockage removed by the Board. The Operations Manager has discussed with the landowner about potential replacement.

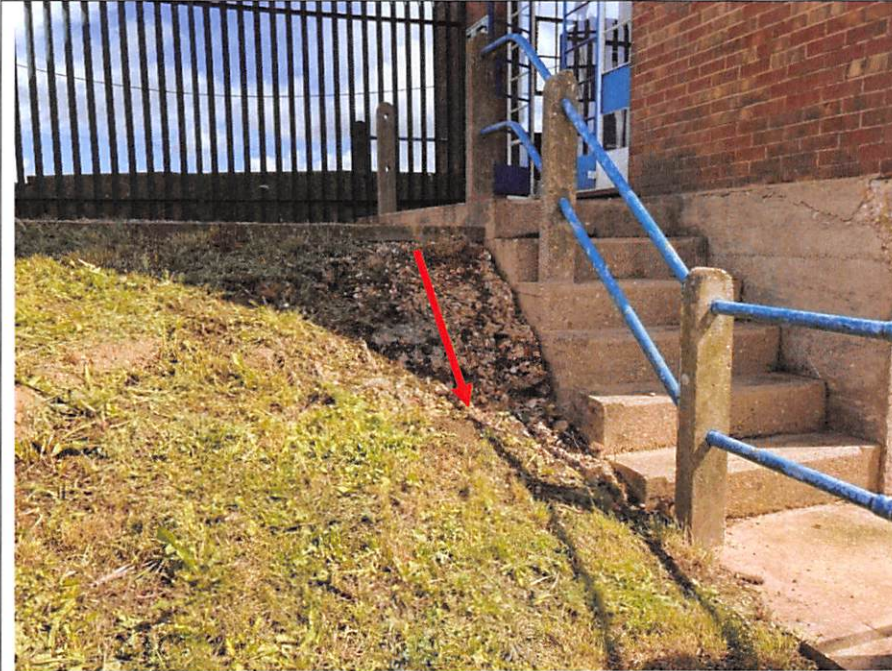
Photograph 1 - West side of pumping station. Settlement of the soils beneath the stairs leading into the pumping station building. Photograph taken looking north. Arrow denotes seepage water flow.

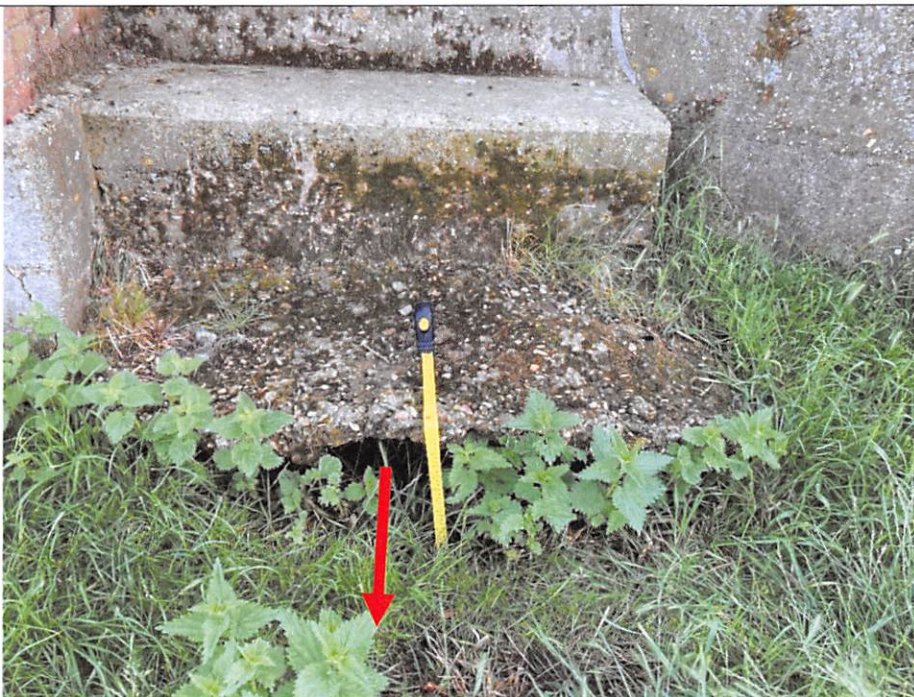
Photograph 2 - A void present beneath the bottom of the concrete steps to the west side of the pumping station as a result of ground settlement. Water has been noted to flow through this void during high water levels. Arrow denotes seepage water flow.

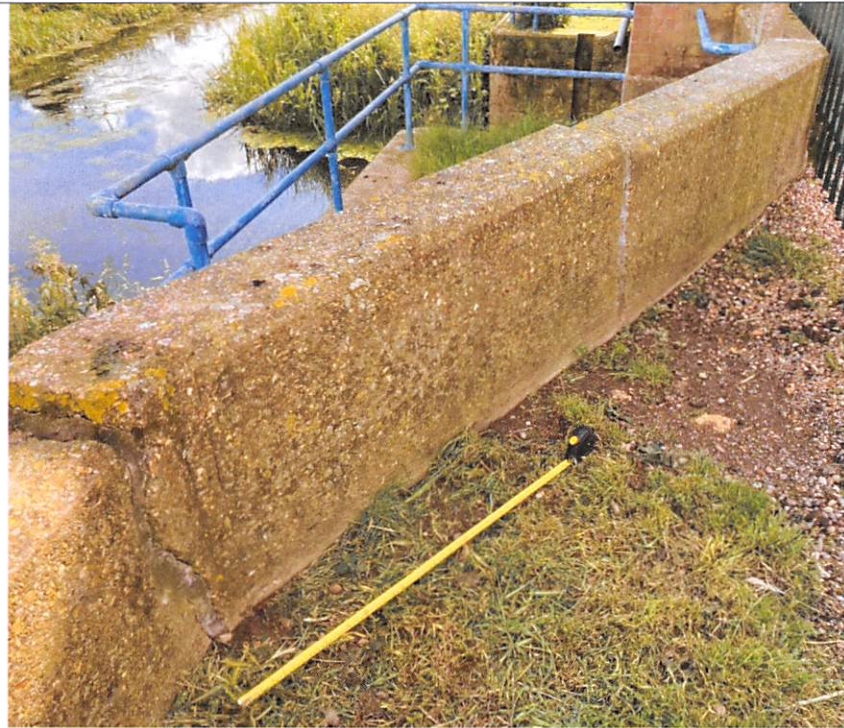
Photograph 3 - Western side of pumping station. Movement and dislocation of the concrete wingwall sections downwards and to the left of view, and evidence of temporary repairs of cracks in the wall. Tape 1m long for scale.

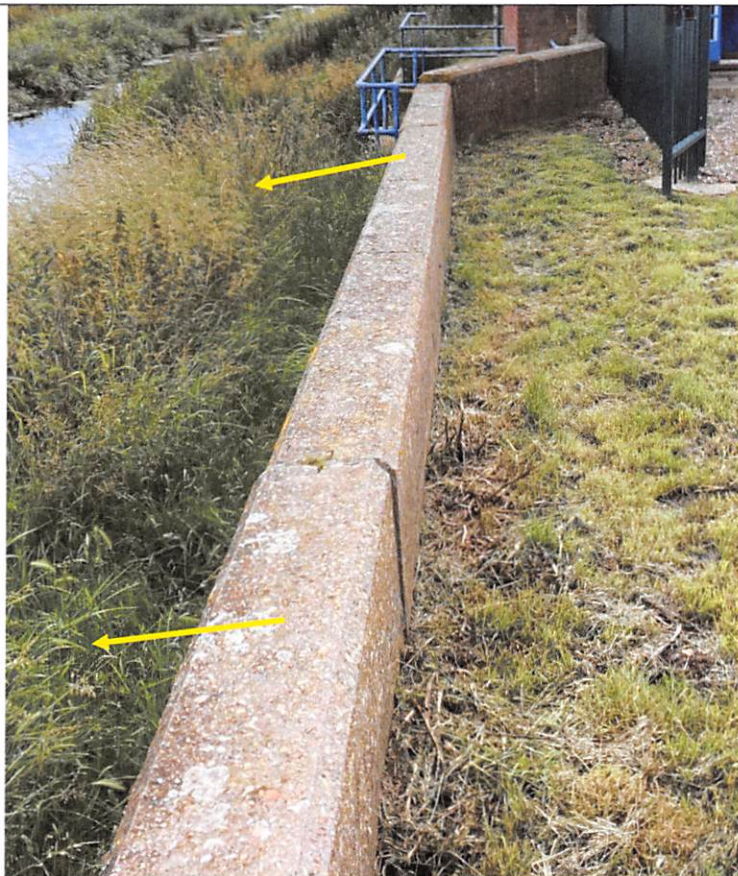
Photograph 4 - Western side of pumping station. Settlement of soils on the northern side of the wingwall. Yellow arrows show indicate rotation of the concrete sections towards the north.

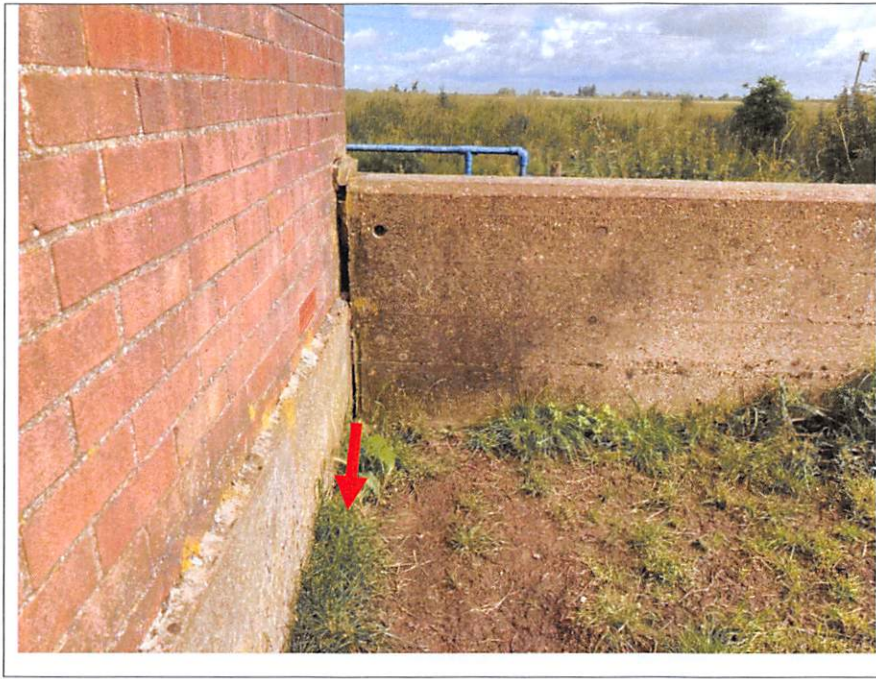
Photograph 5 - Eastern side of pumping station looking north. Wingwall has moved downwards and away from the building to leave a gap through which water flowed. Arrow denotes seepage water flow.
