BLACK SLUICE

INTERNAL DRAINAGE BOARD

Structures Committee Meeting

Tuesday, 19th March 2024 at 2pm

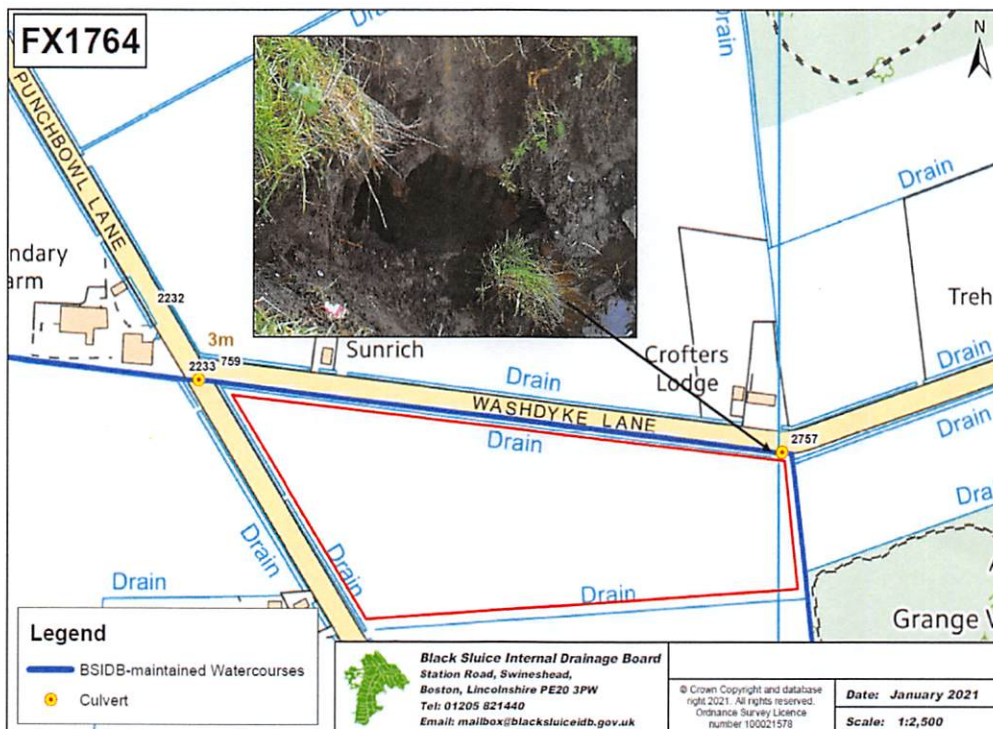
The condition of this culvert continues to be monitored, LCC have been informed about the landowners concerns and the proximity to the highway. The land is tenanted, and the tenant requires the culvert to be replaced.

A contribution may be beneficial and offered towards the replacement of this culvert: £1,000 estimate.

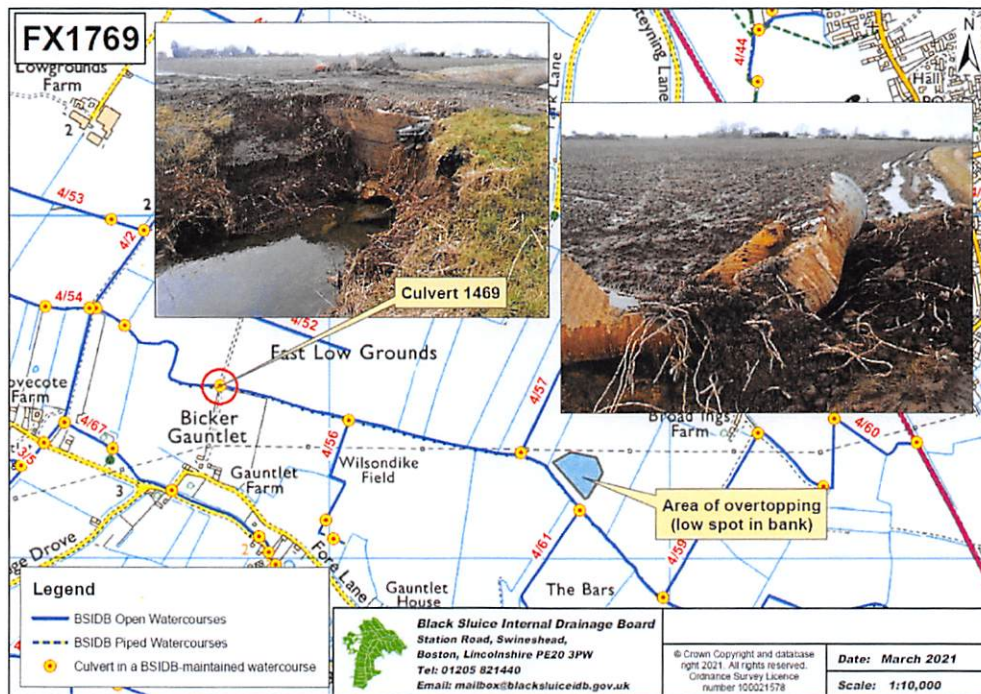
(b) Bicker Fen - No 1469 - FX1769 - 18m x 1200mm Armco (Farm track Field entrance)

This culvert has partially collapsed, the blockage removed by the Board.

A contribution may be beneficial and offered towards the replacement of this culvert: £1,000 estimate.

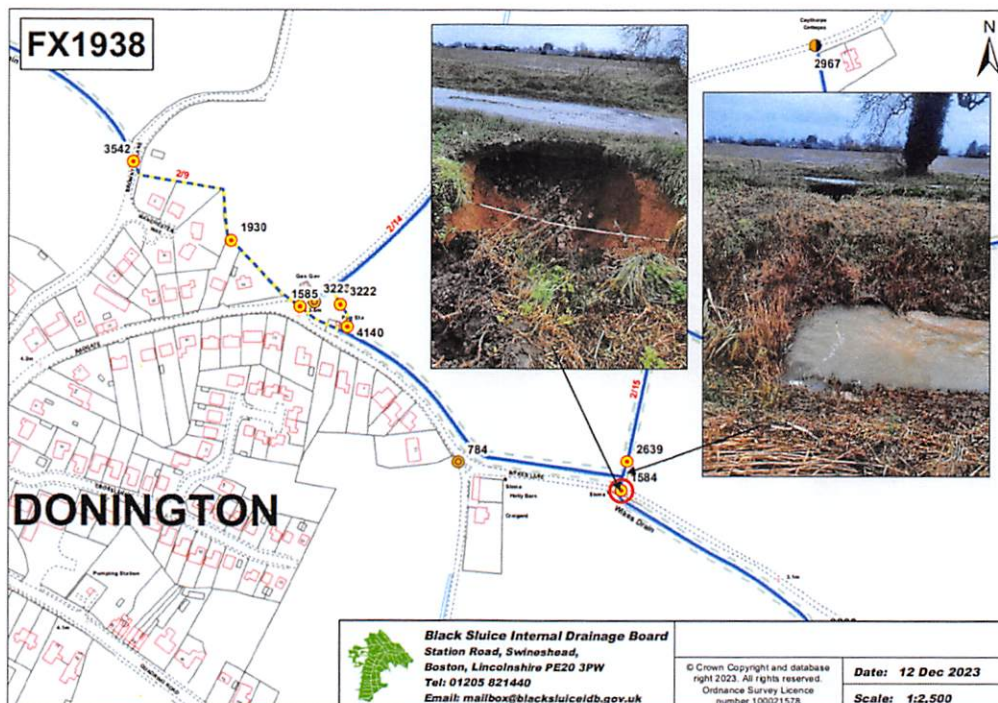
(c) Donnington Wyke Covert Collapse No 1584 – FX1938

This culvert was reported to the Boards Offices on the 12th December 2023 leading to the following chain of events.

As stated it was noted by one of the Board's operatives that water levels were high in the Wykes Drain, no 2/9 upstream of the pumping station.

Further investigation found that culvert 1584 had started to fail adjacent to Wykes Lane where a large hole had opened up in the verge, on the North side of the road, evident from the photographs taken creating a large void. BSIDB operatives attended site to place cones and fencing around the hole.

15.50hrs Copies of these photographs were sent to LCC notifying them of this issue, stating that we had concerns for the integrity of the structure and concern that it would fail, as it was already evident that it was restricting conveyance. Our recommendation was made that the road be closed ASAP.

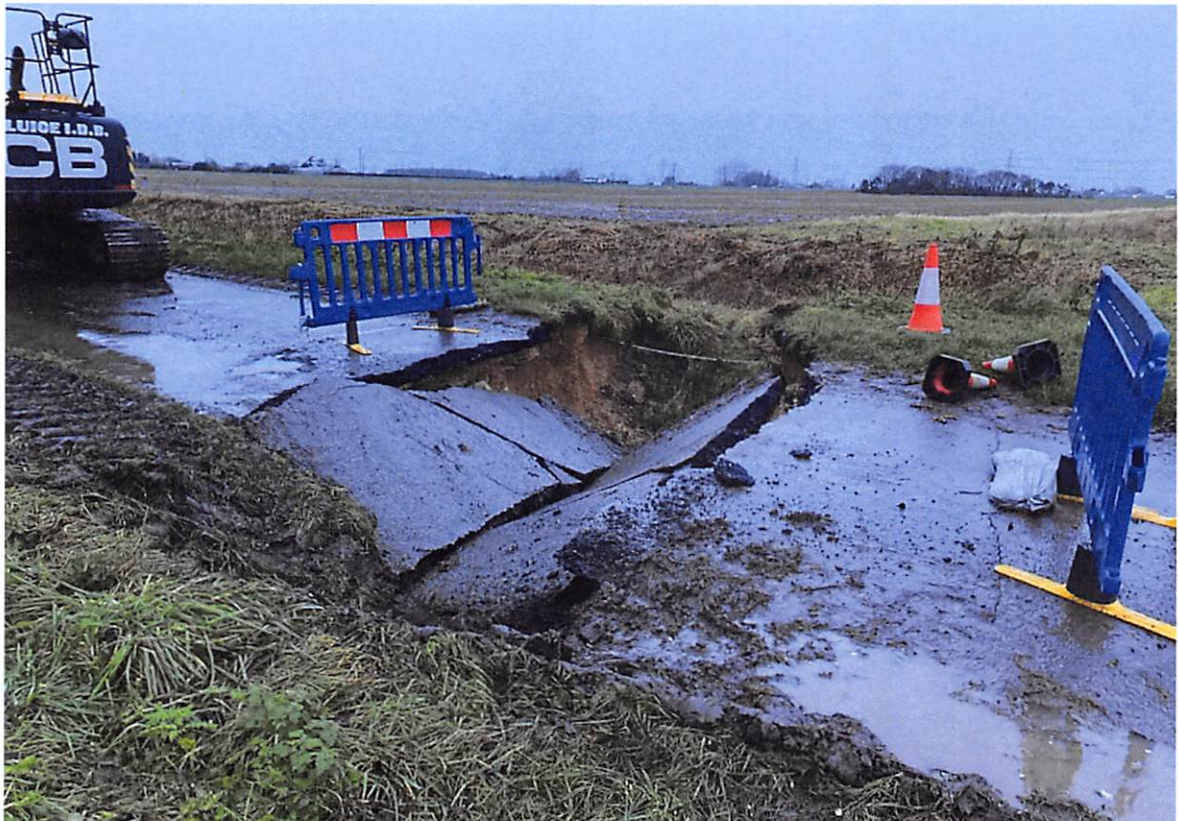
This is how the operatives found the site when they arrived in the morning. It can be seen that despite the machine being parked on the road, a vehicle has driven past it and maybe is the cause of the failure. This photograph was shared with LCC and stated to them that the decision to remove the culvert was not just due to conveyance of flows but also from a Health and Safety viewpoint, due to the failure of the road this was evidently the right decision.

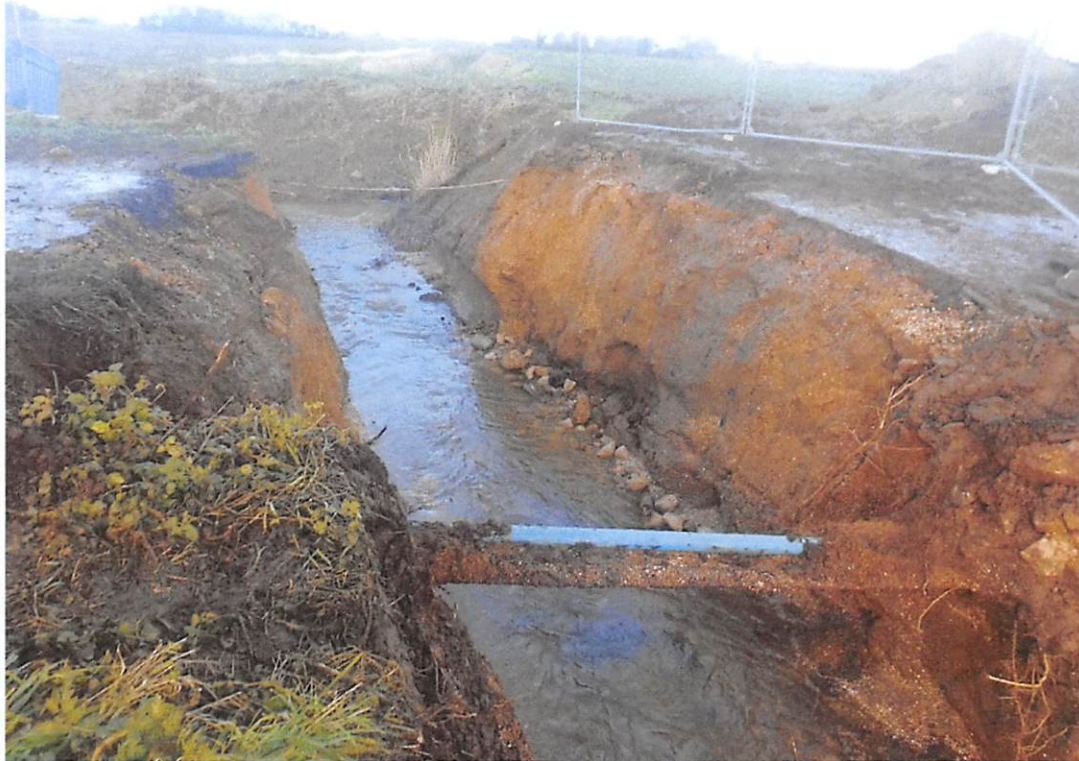
After culvert removed, showing flows reinstated. Harris fencing shown hired by the Board.

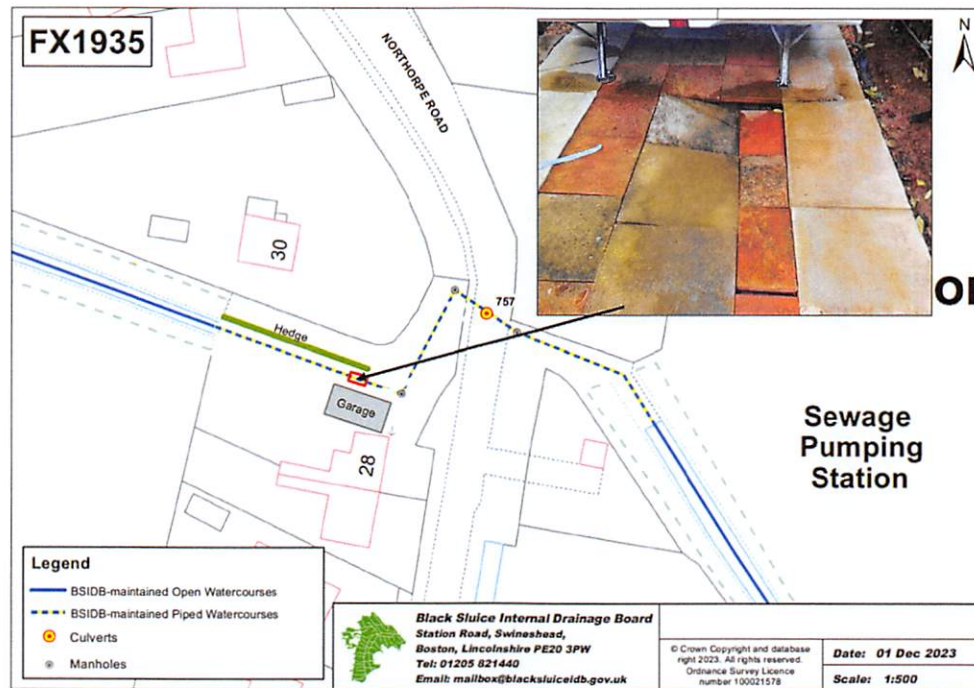
(d) Northorpe Covert Collapse No 757 – FX1935

This culvert was reported on the 8th December 2023 by the home owner who's garden pipe runs through. It has been monitored and with the recent events has steadily got worse. At this moment we are going out to contractors for prices to replace the pipe.
