# Black Sluice Internal Drainage Board

## A G E N D A

**STRUCTURES COMMITTEE - 18 NOVEMBER 2025**

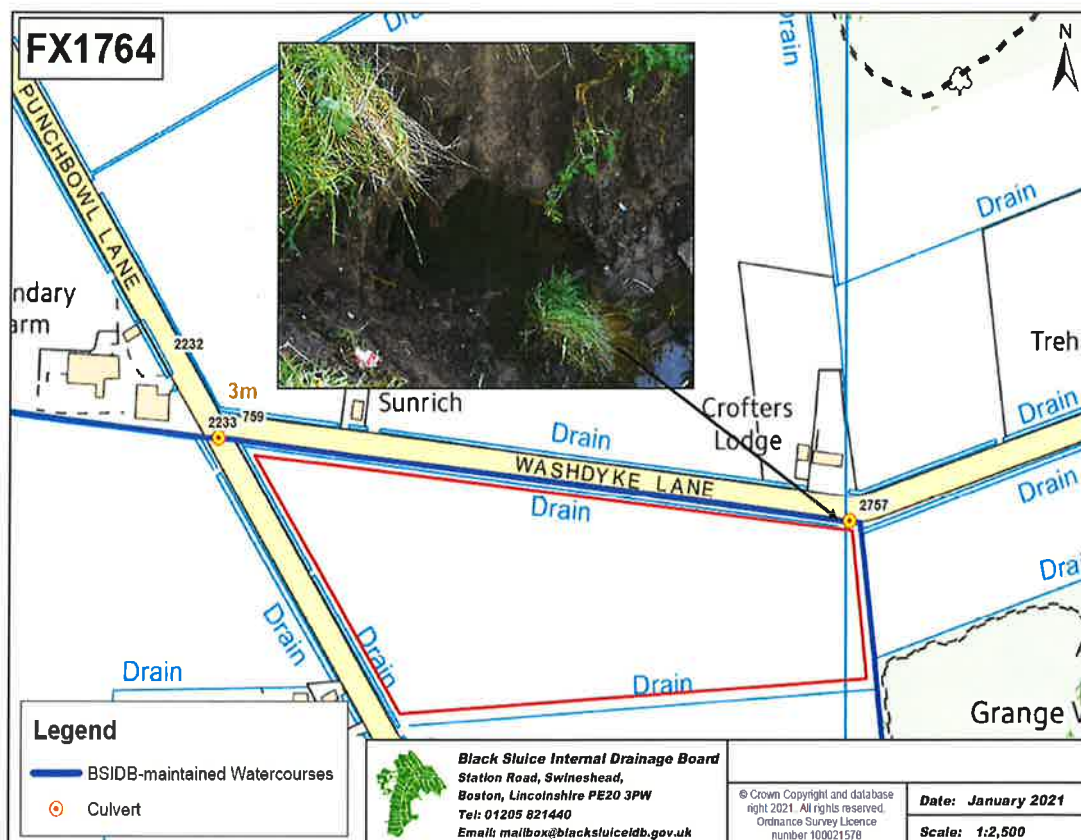
**(a) Boston West - No 2757 - FX1764 - 12m x 600mm Armco (Field entrance, close to road)**

The condition of this culvert is continuing to be monitored, LCC have been informed about the landowners concerns and the proximity to the highway. The land is tenanted, and the tenant requires the culvert to be replaced.

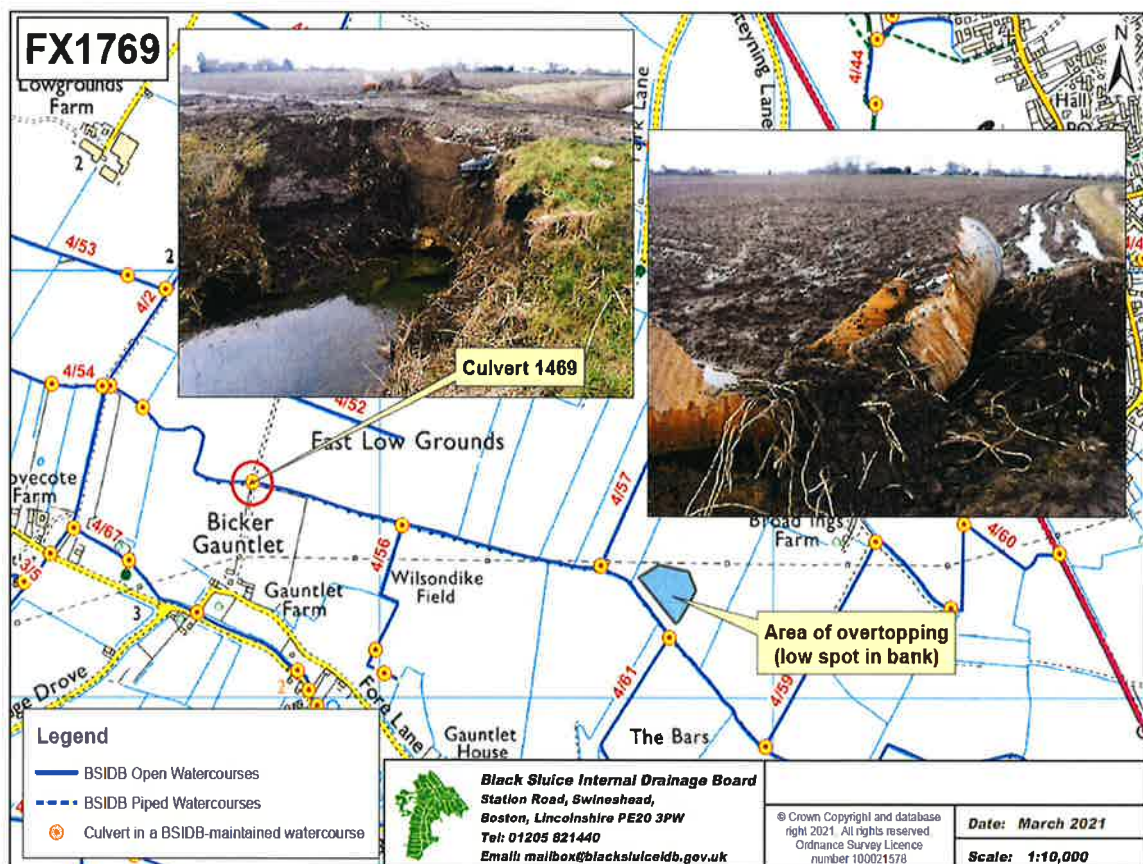
**(b) Bicker Fen - No 1469 - FX1769 - 18m x 1200mm Armco (Farm track Field entrance)**

This culvert has partially collapsed, the blockage removed by the Board. No further action has been taken with this culvert by the landowner to replace the culvert.

A contribution had been and offered to the landowner towards the replacement of this culvert but as yet has not been taken: £1,000 estimate.

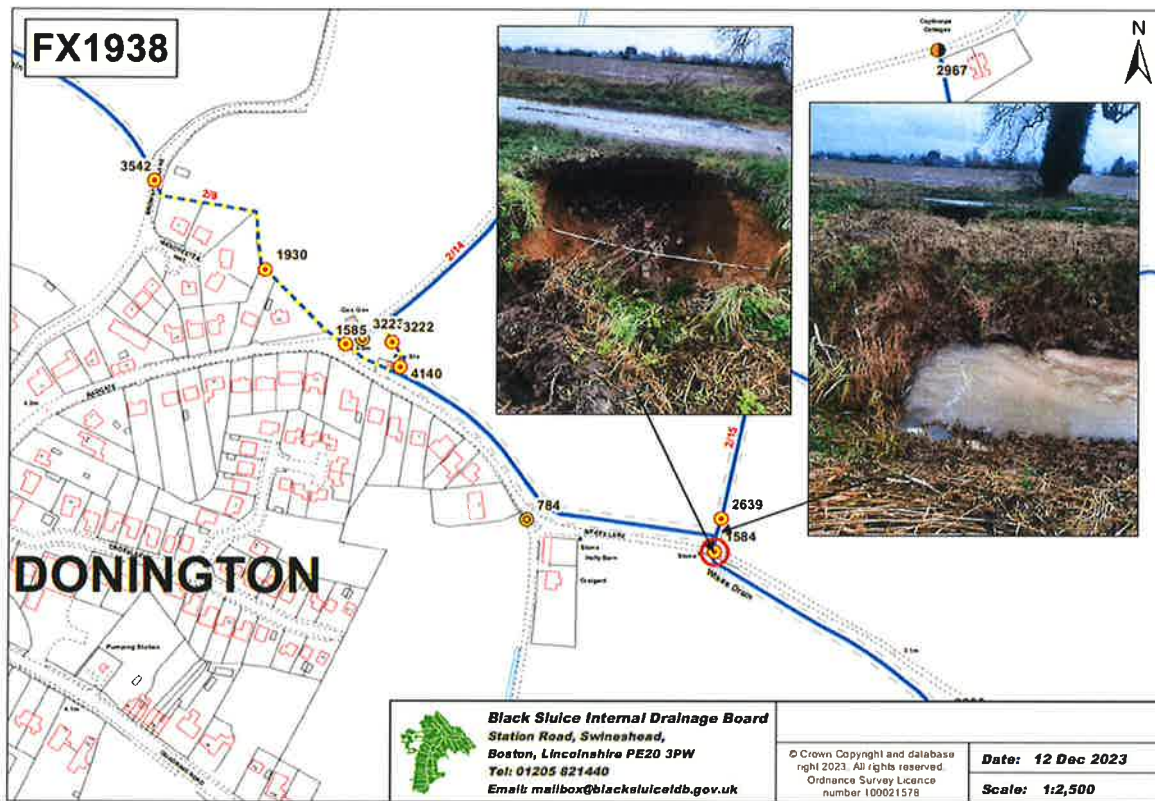
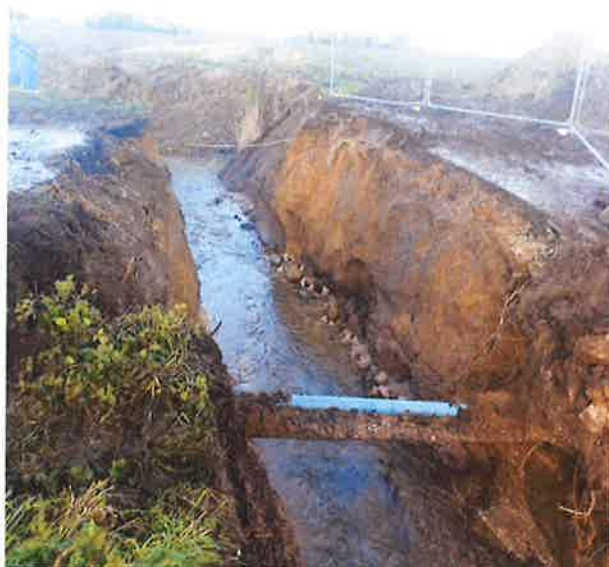
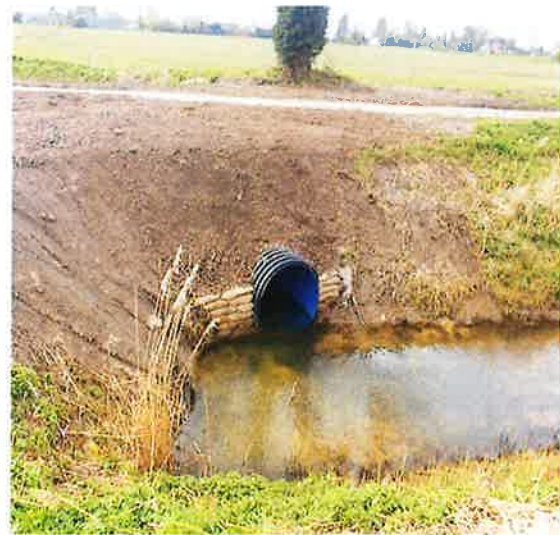
**(c) Donnington Wyke Covert Collapse No 1584 – FX1938**

This culvert was reported to the Boards Offices on the 12<sup>th</sup> of December 2023 and has now been completed by LCC appointed contractor.

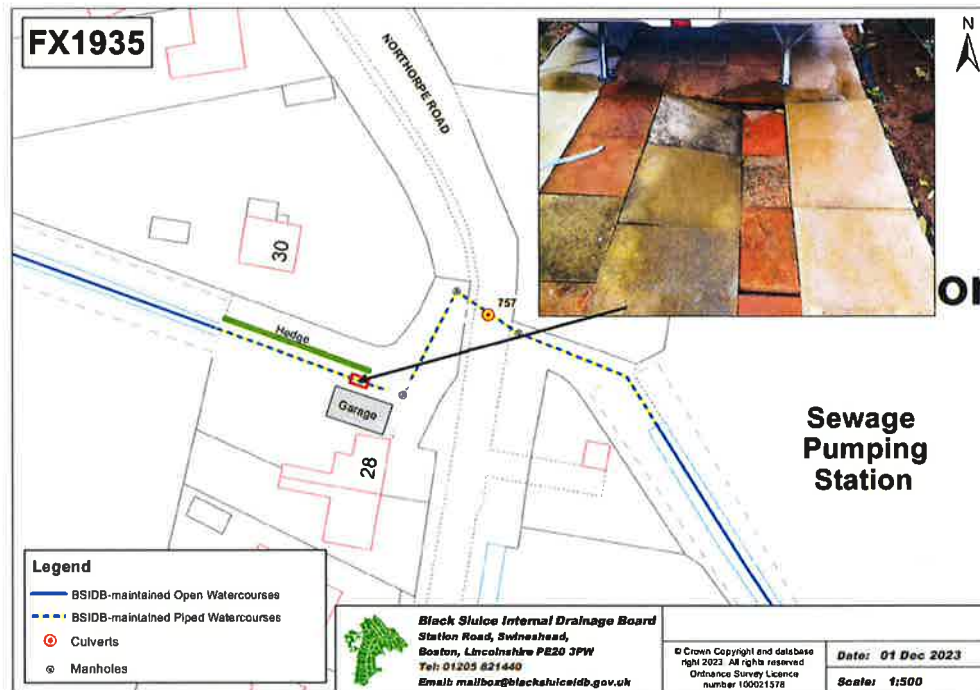
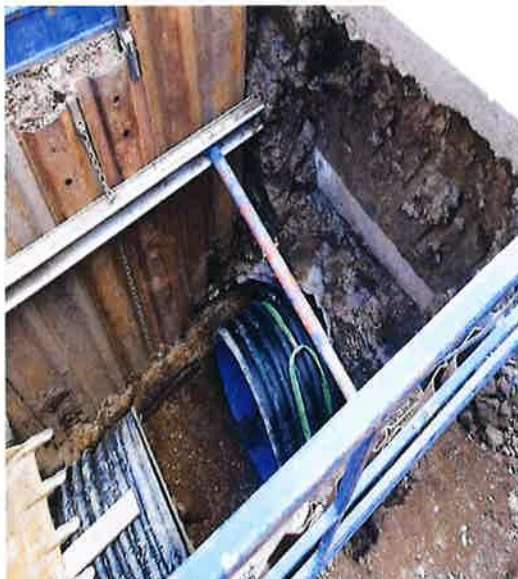
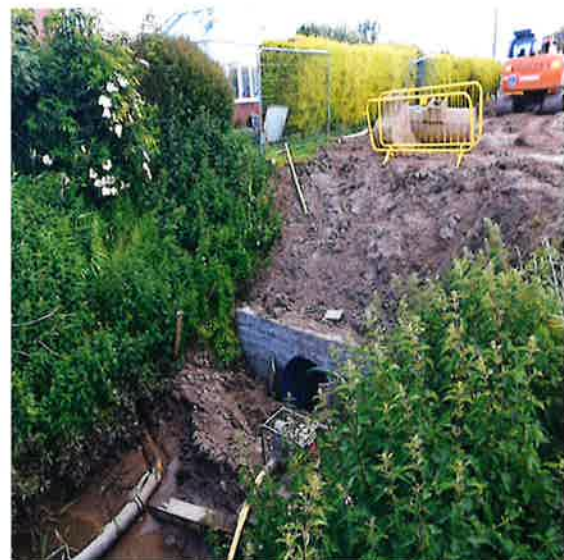
#### (d) Northorpe Culvert Collapse No 757 – FX1935

This culvert was reported on the 8<sup>th</sup> of December 2023 by the homeowner whose garden pipe runs through. It was agreed that the pipe was to be replaced and the works were put out for tender, and a contractor was appointed. All works in the garden of Mr & Mrs Issitt have now been completed and garden reinstated.

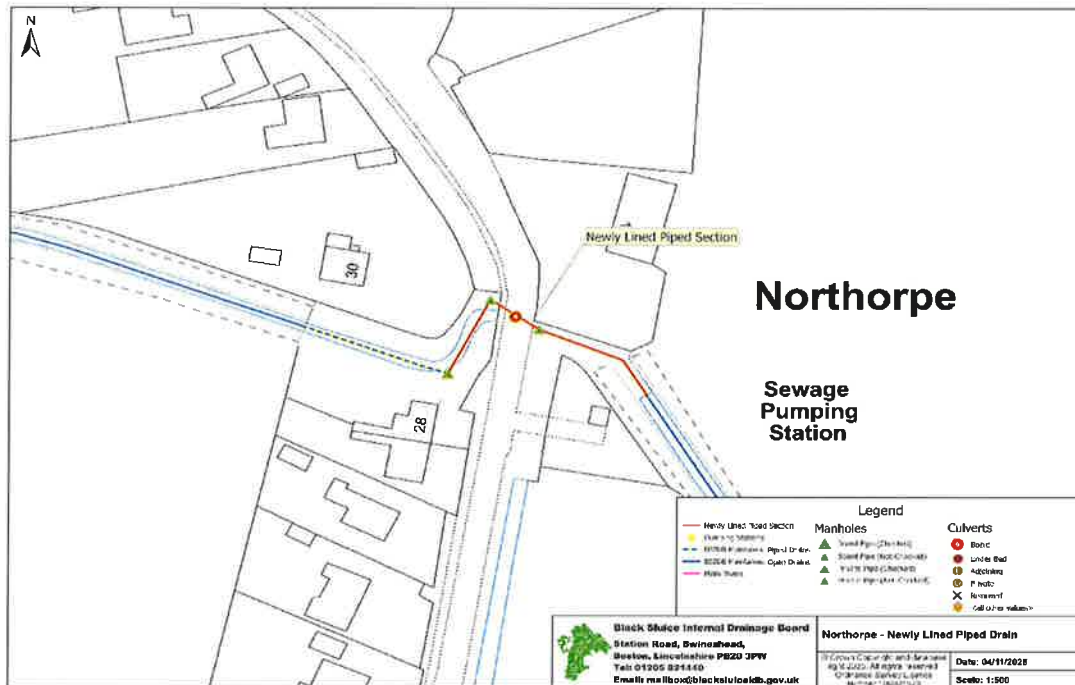
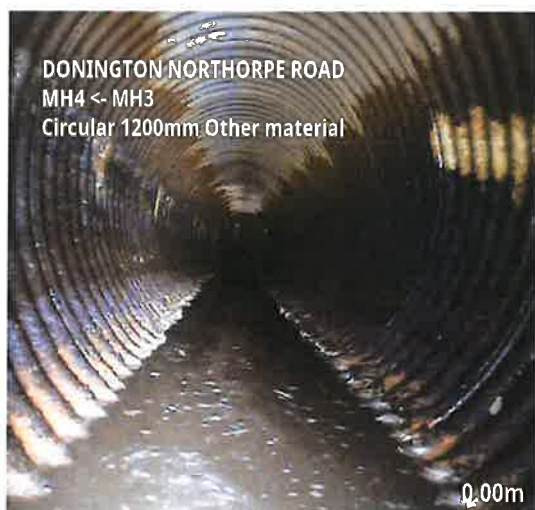
**BEFORE**

Following on from the above work the board had a CCTV inspection of the remaining culvert sections of the culvert. It was found that although the condition of the Armco sections appeared to be satisfactory there was no assurance that the pipe hadn't corroded on the outside. it was agreed that a price to line the culvert was to be obtained. McAlister's was the successful contractor at £105,479.05. with funding being secured under the IDB fund.

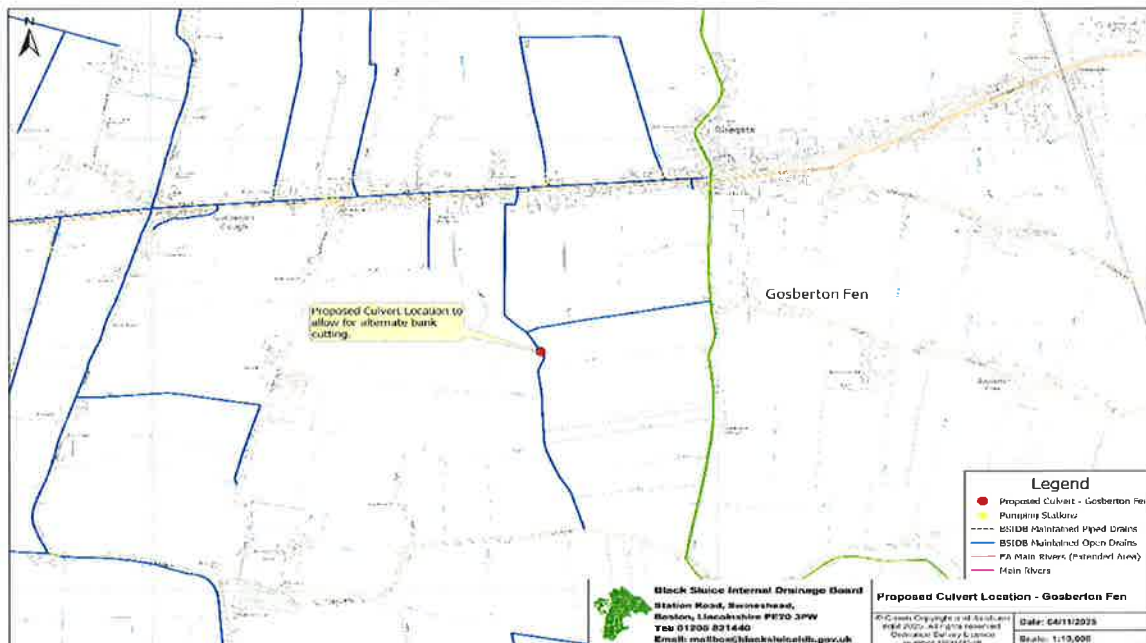
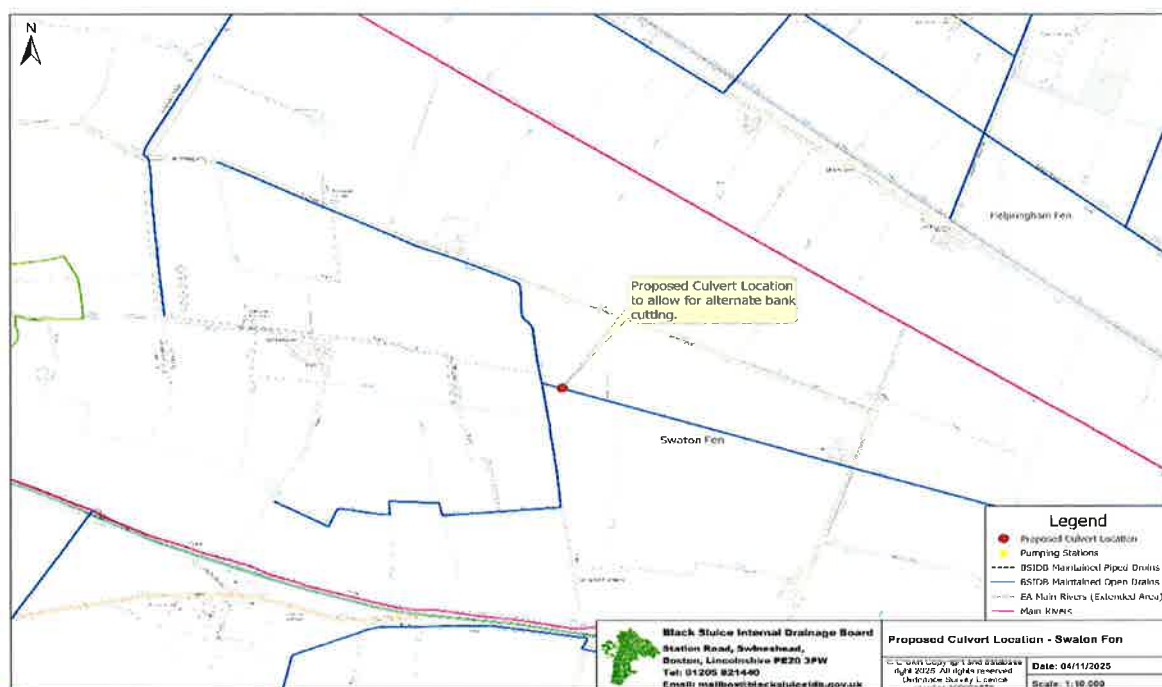
## 2. Additional access culvert for Board's Machinery.

The routes of the excavators are being constantly reviewed and it has been identified that the addition of two new culvert would enable the Board to complete their works more efficiently by having less moves with the Unimog and allowing the cutting of both sides of the bank inline with our Bio-Diversity Plan.
